Factors affecting the service life of poles in BC

Leon A. Joseph

**British Columbia Hydro
Engineering Quality Management
Burnaby, B.C.**

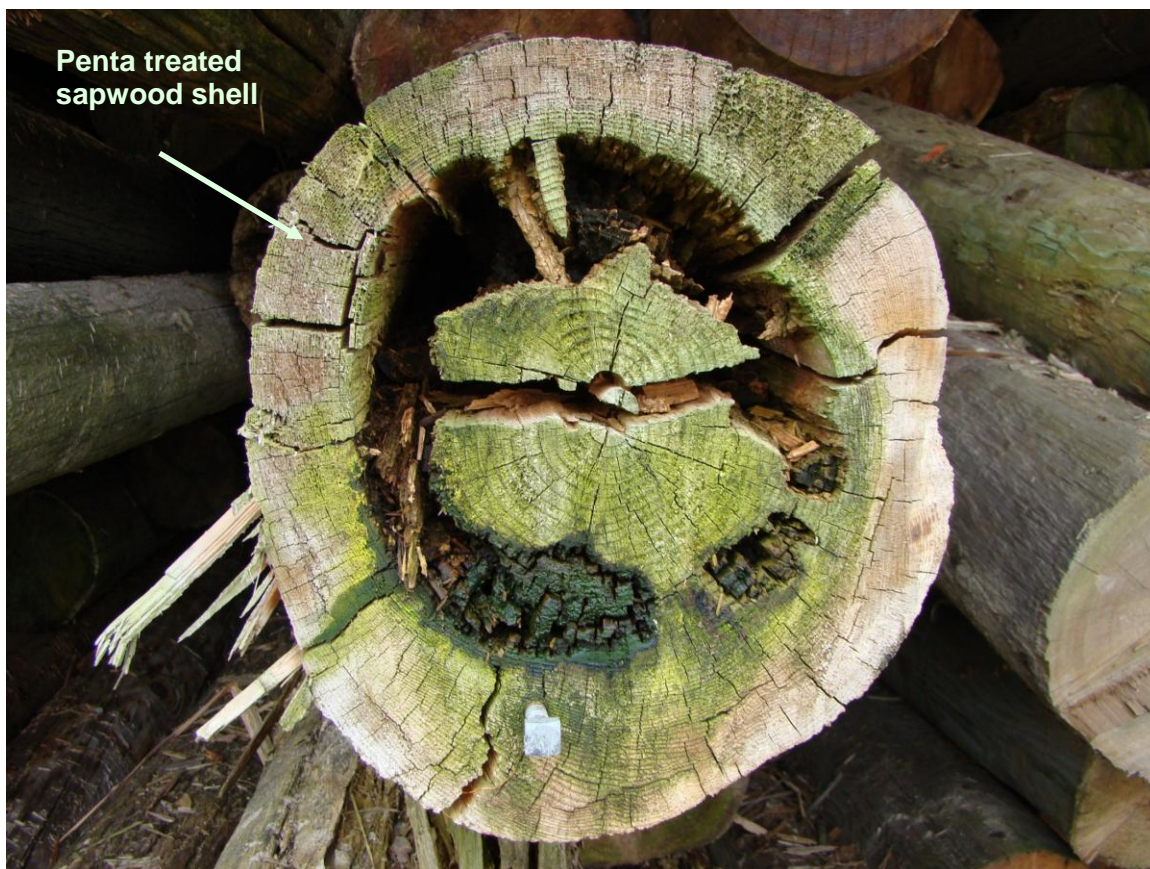
Photo 1

The value of treated wood is clearly seen in photo 1, which shows the butt of a 26-year-old, Pentachlorophenol treated Lodgepole pine pole. Though the heartwood of the pole contains extensive damage caused by brown rot fungi, the treated sapwood shell is still in very good condition. This raises an important strength-related point for discussion regarding a weakness in the minimum chemical penetration requirement for Lodgepole pine and Douglas fir poles as presented in the CSA 080 Wood Preservation Standard.

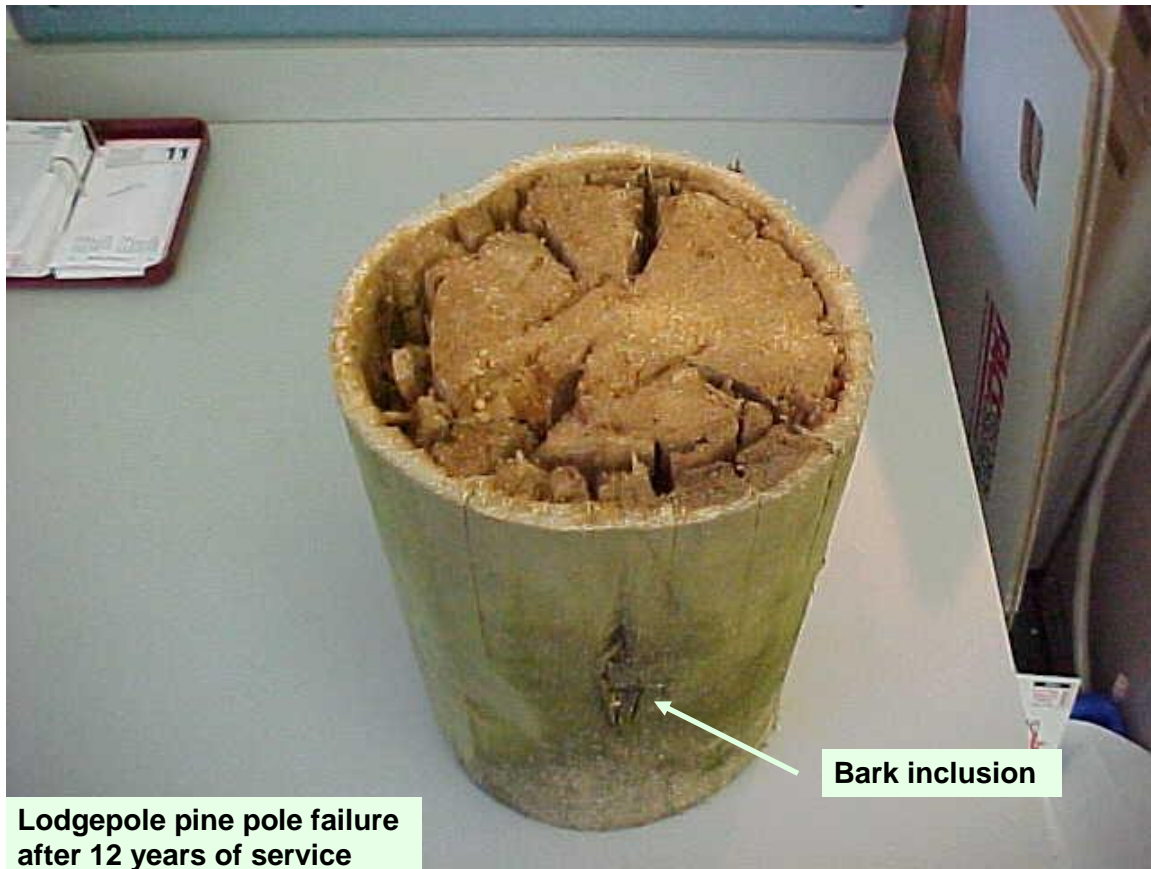
Photo 2 & 3 highlight another characteristic of Lodgepole pine that has proven to be very problematic for BC Hydro. Bark inclusions are a common characteristic that can range in number from a single pocket to dozens scattered the full length of a pole. The problem these inclusions present concerns the depth of the treated shell at the base of each inclusion. Premature failure investigations have determined that internal decay in Lodgepole pine is often linked to bark inclusions in poles that have a minimal yet acceptable sapwood shell thickness.

This was determined by extracting wood cores from poles that contained inclusions and decayed heartwood. The intent was to compare the depth of the treated shell in close proximity to an inclusion with the depth of the treated shell at the base of an inclusion. In most cases, the wood core samples clearly showed a dramatic difference in the thickness of the treated shell. For example, if the wood core that was extracted close to a pocket had a treated shell depth of 25mm (1"), the core extracted from the base of the pocket often would only have a treated shell depth of approximately 6mm (1/4"). In some cases, the core samples revealed that there was no chemical penetration at the base of some inclusions.

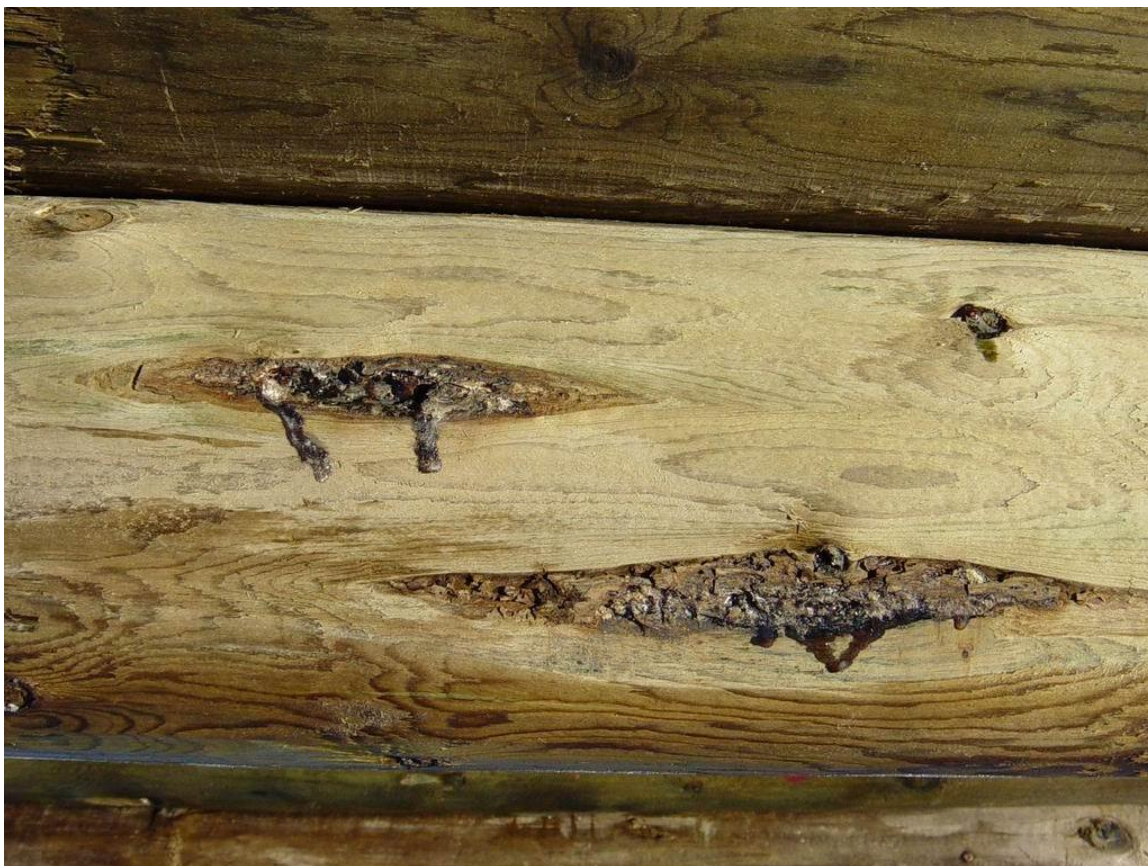
Photo 3

Paragraph 4.4.8.2 of the CSA 015 Wood Utility Pole Standard restricts the presence of bark inclusions in the ground line zone of a pole, but does not limit their presence or number outside of this zone. BC Hydro's investigations noted that inclusions located above the ground line zone were serving as doorways for fungal and/or insect attack, especially if the bark was not completely removed from the inclusions. (photo 3)

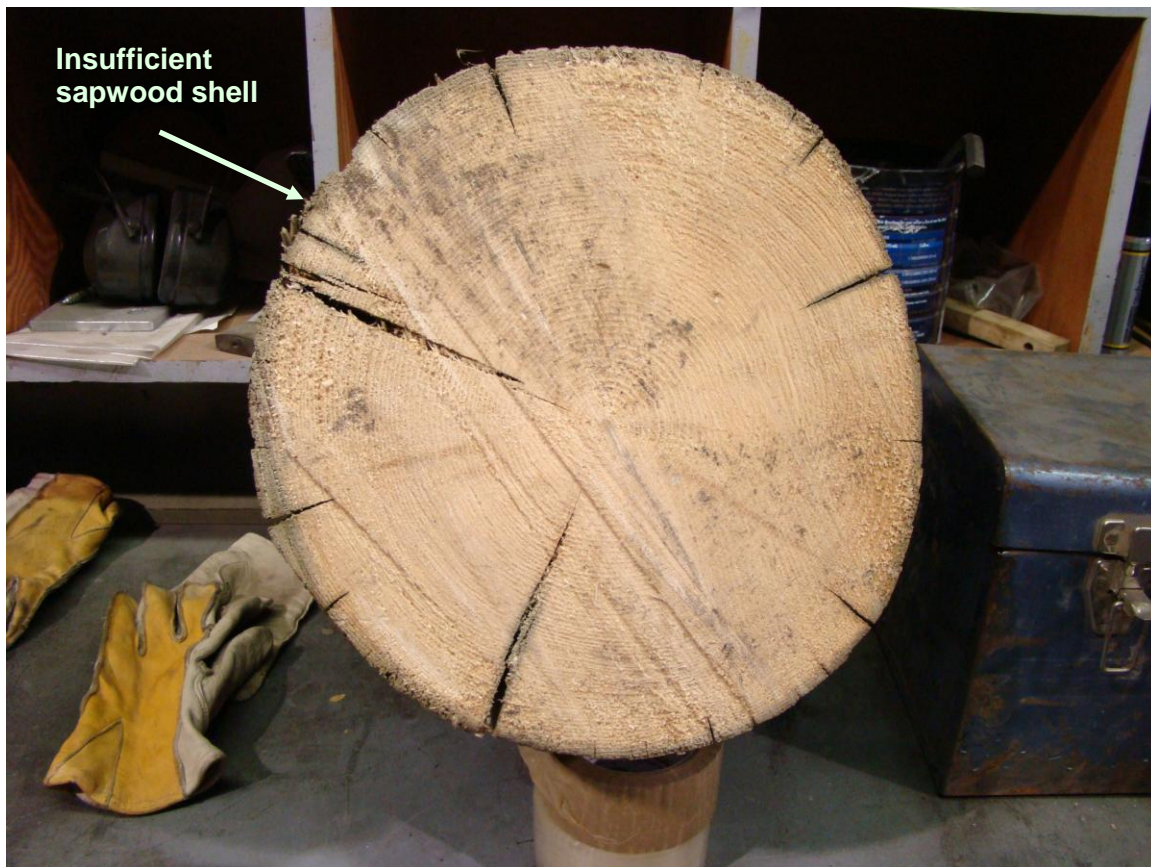
Once again, the focus has been on Lodgepole pole pine. The majority of the failures were linked to poles that did not have an adequate treated shell. Photo 4 shows the cross section of a pine pole cut at approximately 280 cm (9') from the butt. The ground zone of this pole contained extensive brown rot fungi, which caused the pole to fail after only 13

years of service. It is clearly evident in the photo that the pole did not remotely conform to the 19mm chemical penetration requirement specified in the CSA 080.2 Wood Preservation Standard, Table 11. (photo 4)

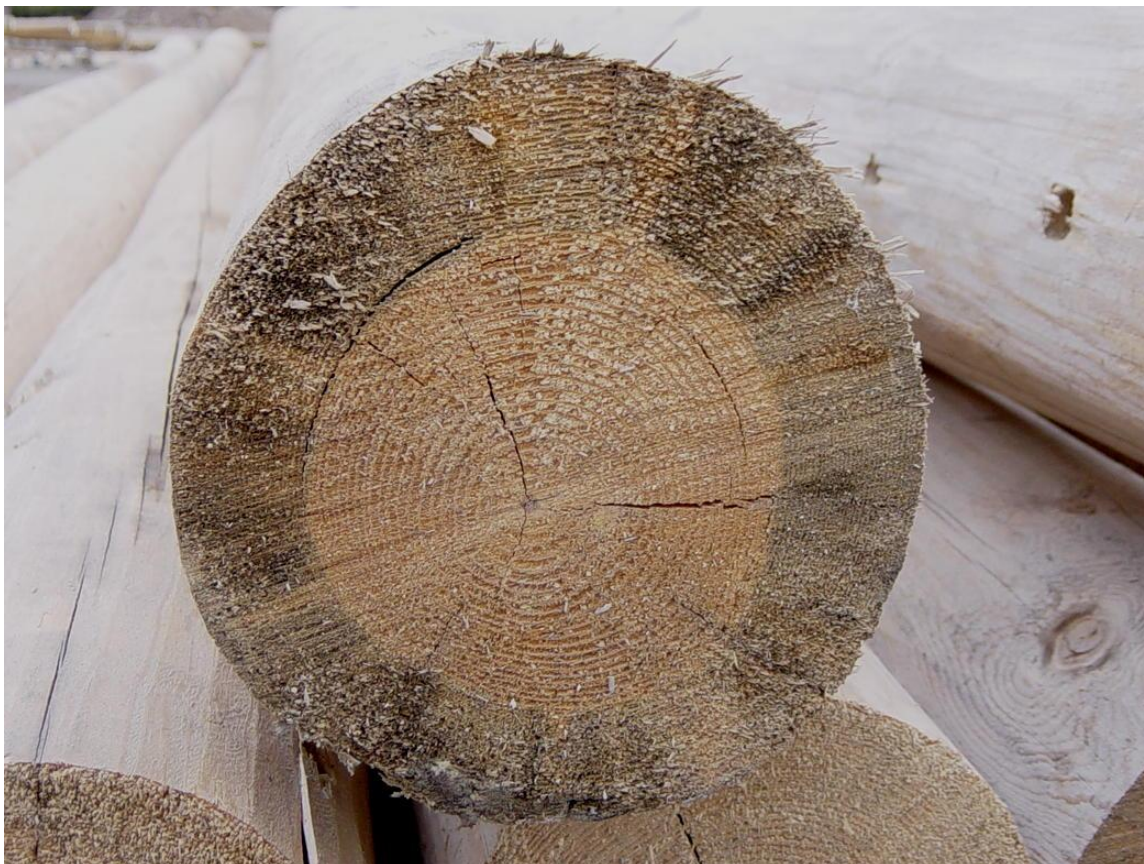
Photo 5

It is generally accepted that the presence of blue stain fungi (photo 5) does not adversely affect the strength of the discolored wood fiber. The concern is that, the longer the dead trees stand in the forest, the greater the possibility that decay fungi will develop in the stained sapwood. One of BC Hydro's suppliers has reported that a high percentage of the raw pole stock arriving at their plant contains pockets of brown rot fungi. As the race to salvage merchantable material continues, the supplier anticipates that the rejection rate of raw stock they are receiving will increase. The concern that utilities need to consider is that the presence of incipient decay can very easily go undetected. If the sapwood of a pole contains incipient decay prior to treating, it is very possible that the bending strength of the infected pole is lower than required for the particular class of pole.

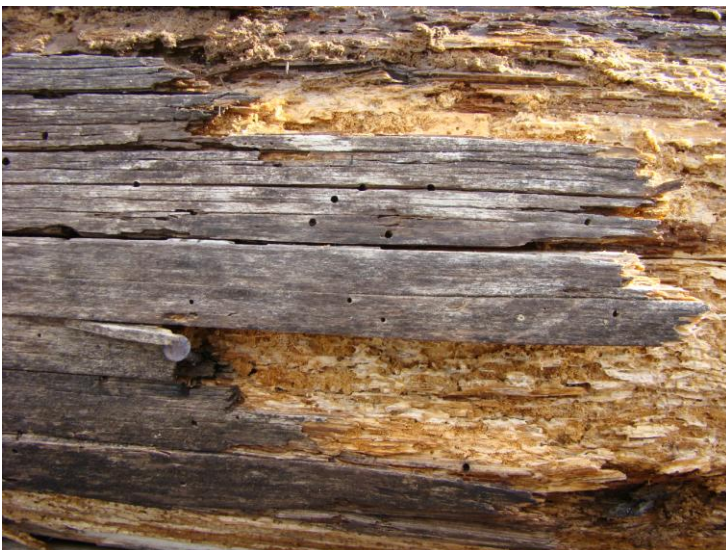
Photo 9 shows the extent of damage that may be present in a butt-treated pole installed in a coastal area of the Province. (photo 9) Though the shell of the pole in the photo appeared sound, just below the surface there was extensive decay. Line crews have to be very alert to the fact that this type of damage can be present at any location on a butt-treated pole.

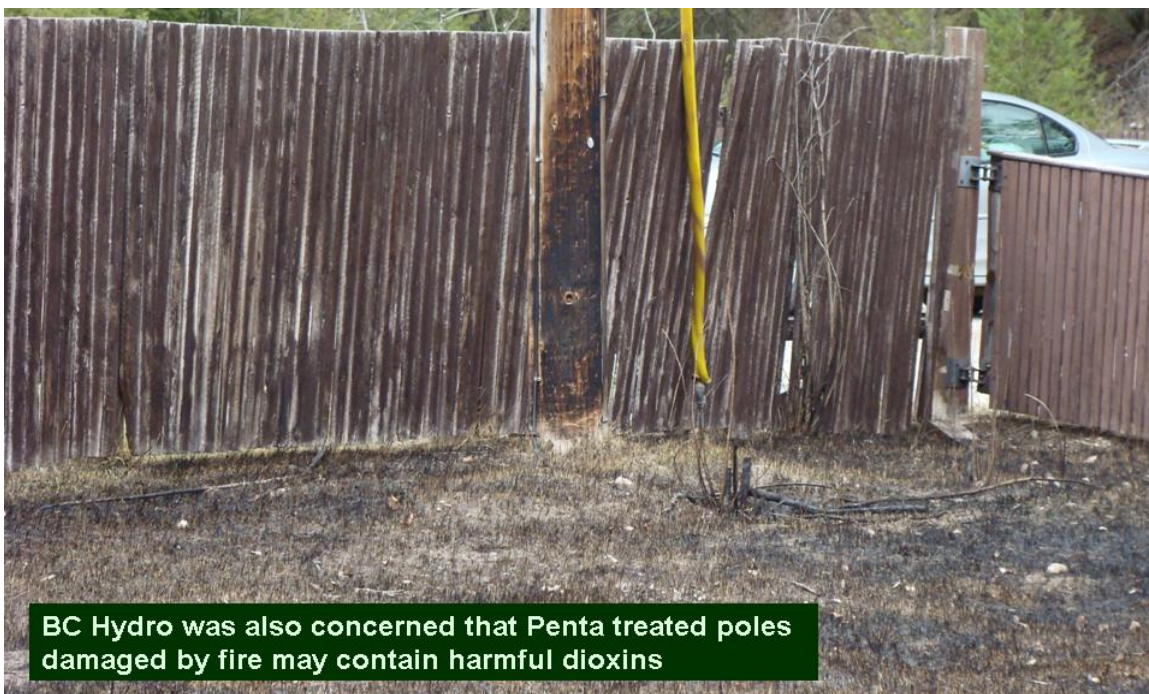
Photo 12

BC Hydro was also concerned that Penta treated poles damaged by fire may contain harmful dioxins

Another concern that BC Hydro had regarding Pentachlorophenol was the possibility that workers or residents could be exposed to trace levels of harmful dioxins. This concern primarily focused on poles damaged during grass burning or forest fires. Though most research claims that the type of dioxins that might be present in Pentachlorophenol are not harmful, it is acknowledged that exposure to extreme high temperature can dislodge chlorine molecules, thus altering the toxicity of the dioxins.

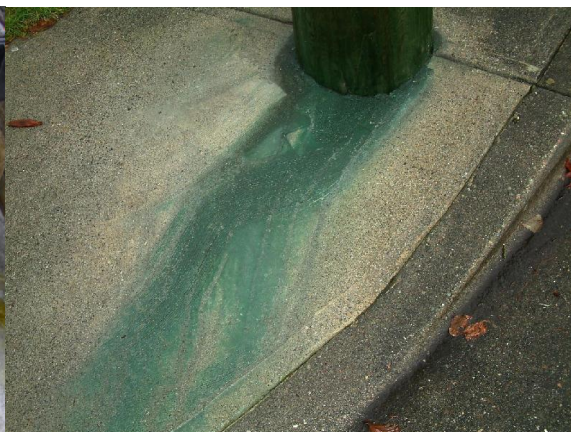
Photo 17 presents an example of the level of chemical bleeding that can occur when a frozen pole thaws out after installation. The pole in the photo is situated on the corner of a busy street in North Vancouver. It was very fortunate that the individual who detected the problem did not make it a public issue. Incidents like this have the potential to spark a great deal of negative publicity. As soon as the problem was reported, BC Hydro dispatched a crew to wash the sidewalk with a special cleaner.

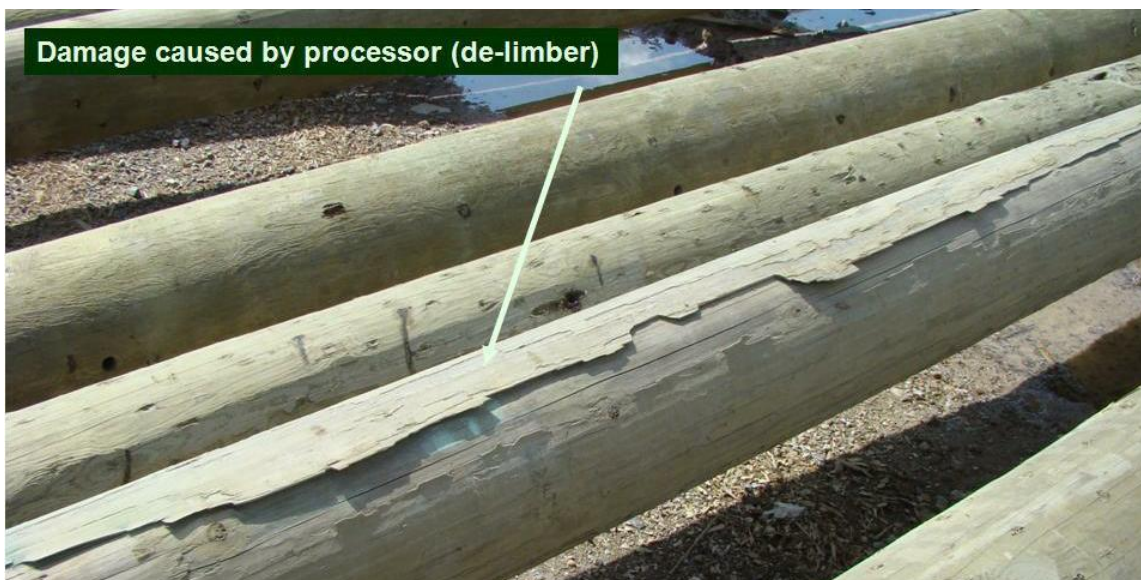
Photo 18

The damage that is clearly visible in the photo was caused by a mechanical processor, which is used to remove the limbs of a tree. During branch removal, a notice operator may apply too much pressure to the rollers that feed the tree through the de-limber. This usually happens during the winter months when there is ice and snow on the trees. When the rollers begin to slip, the operator applies more pressure in attempt to hold the tree in place. If the pressure is excessive, the rollers can crush the tree's outer growth rings. The resulting damage is not evident until the moisture content of the wood is well below the fibre saturation point. Eventually, the damaged layers will begin to cup and separate from the body of the pole.

This poses a danger to line personnel, who may have to climb a pole at times when visibility is poor, such as, night or during harsh weather conditions. The splintered fibre can cause a climbing spur to kick out or it can slice through the climber's protective clothing and cause an injury.

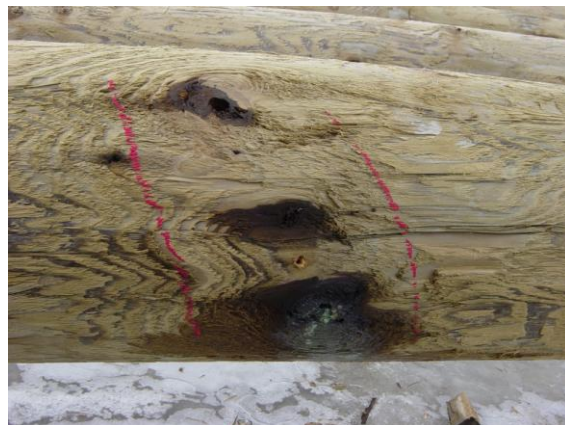
Photo 20

A clear sign of internal rot is chemical bleeding from soft knots and drilled holes. (photo 20) This condition is most prevalent shortly after a pole has been removed from the treating cylinder. After a few days, the bleeding will usually stop. Other than a slight discoloration around the knots and the holes, there may be no evidence that the pole has internal damage. This emphasizes the importance of performing a physical examination of every pole as part of the post-treatment quality control procedure.

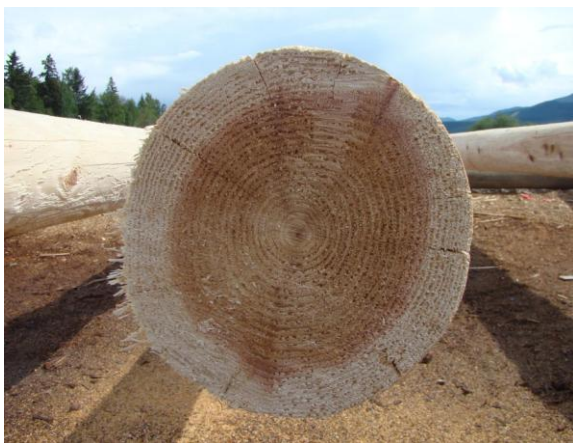
Photo 21

Over the past several decades, BC Hydro inspectors have noted a gradual increase in the sapwood thickness of many Distribution-size cedar poles. (photo 21) Though increased sapwood depth does not impact the strength of a pole, it does make achieving BC Hydro’s treatment requirement of 100% sapwood penetration more difficult. On a positive note, maintenance personnel have found that CCA treated cedar poles with deep sapwood rarely require a pole bandage.

It is believed that the deeper sapwood in poles is linked to climate change and today’s modern reforestation practices. Many areas of the province of British Columbia are enjoying longer growing seasons and higher levels of precipitation. These factors combined with modern silviculture practices such as, the spacing of seedlings and forest thinning appear to be affecting the way trees grow.

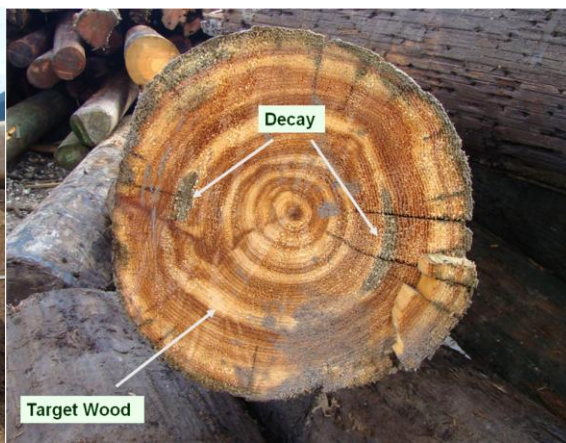
Photo 22 presents an example of how pockets of decay can form in the bands of target wood. If these bands are close to the surface, a pole may experience a condition known as “banana peeling”. This occurs when decay develops along the growth rings, immediately under the treated sapwood shell. As the decay spreads, the shell will separate from the

body of the pole presenting a climbing hazard for line crews. Eventually, the decay will also consume the heartwood to a degree that the pole will require replacement.

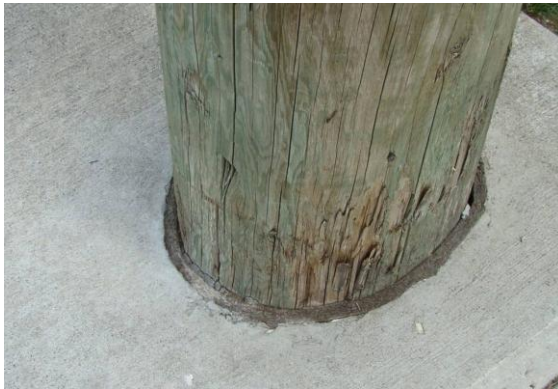
Photo 25

Poles installed in sidewalks are a very common sight in most urban areas. (photo 25) While it may look ascetically pleasing, a pole installed in concrete or pavement may be providing an ideal environment for decay to develop. If the water table under the sidewalk is close to the surface, the concrete can serve as a barrier that inhibits evaporation during periods of hot weather. This can create a greenhouse environment under the concrete in which decay can flourish.

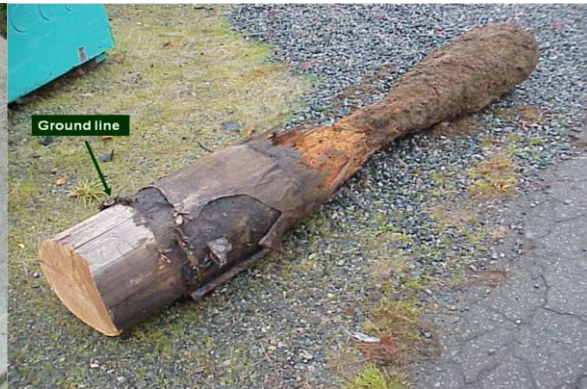
Photo 26 provides an example of a pole damaged by soft rot fungi. The presence of soft rot and the location of the decay are both very unusual. Decay normally occurs in the ground-line zone of a pole, not at the depth shown in the photo. The tests performed during maintenance inspections would not detect the presence of this type of damage. When several poles were discovered to be in a similar condition, BC Hydro's Quality Management department attempted to isolate any factors that the poles had in common.

The most significant factor was the development of soft rot, which is not normally found in a pole. This was attributed to the unusually high moisture content of the soil where the poles were installed. The second factor was that all of the poles were installed in either concrete or pavement. BC Hydro believes that these two factors created an ideal environment that precipitated the development of soft rot. The lesson learned in this case was that poles installed in a sidewalk or pavement should have a buffer zone of drain rock to facilitate evaporation and drainage. For added protection, it has been suggested that barrel shelves could be implanted in a sidewalk to keep the drain rock in place.

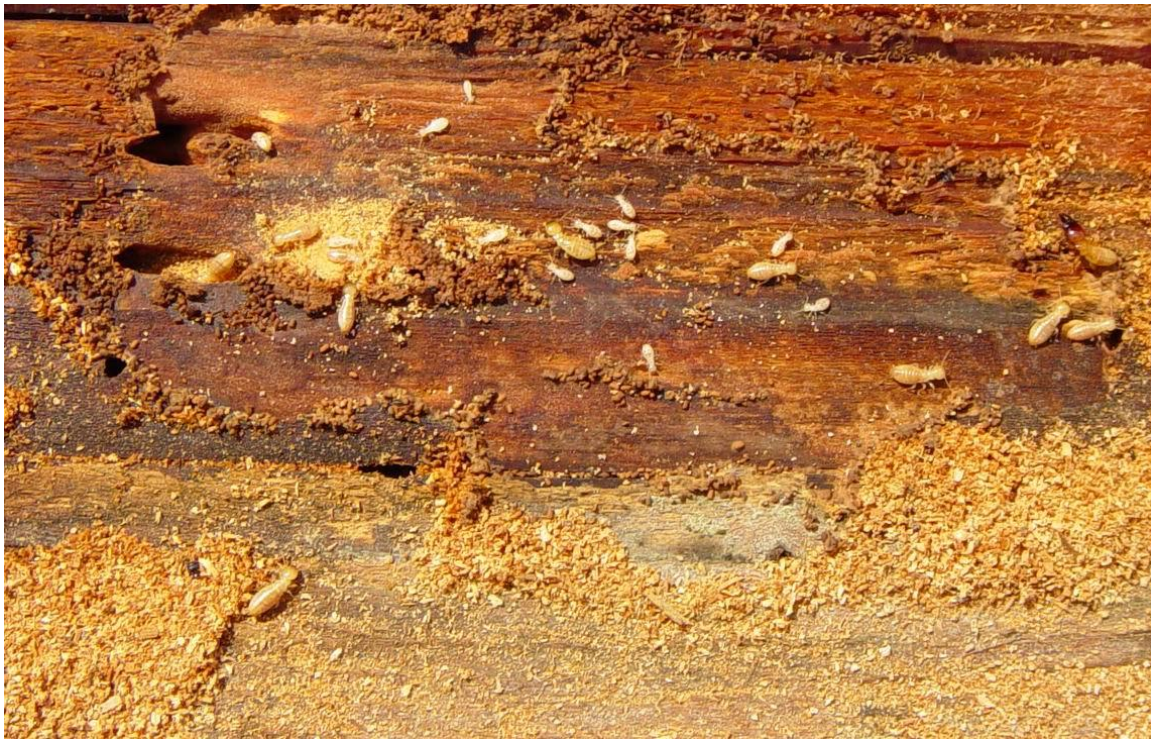
Photo 27

In recent years, ***Termite infestations*** (photo 27) have become increasingly common in the southern areas of the Province. BC Hydro believes that climate change is encouraging termites to expand northward into areas not considered termite zones. It may also be accelerating the population growth of termite colonies.

The presence of termites in a pole presents a threefold problem. First, termites can inflict a great deal of damage in a very short span of time. BC Hydro's maintenance program commences after a pine pole has been in the ground for (14) years and (20) years for a cedar pole. Follow-up inspections are performed every (8) years for the remainder of a pole's service life. If termites infest a pole prior to the first inspection or in the 7th year thereafter, the extent of the damage will usually exceed the limitations defined in the maintenance procedures. The inspector will have no choice but to condemn the pole and tag it for replacement.

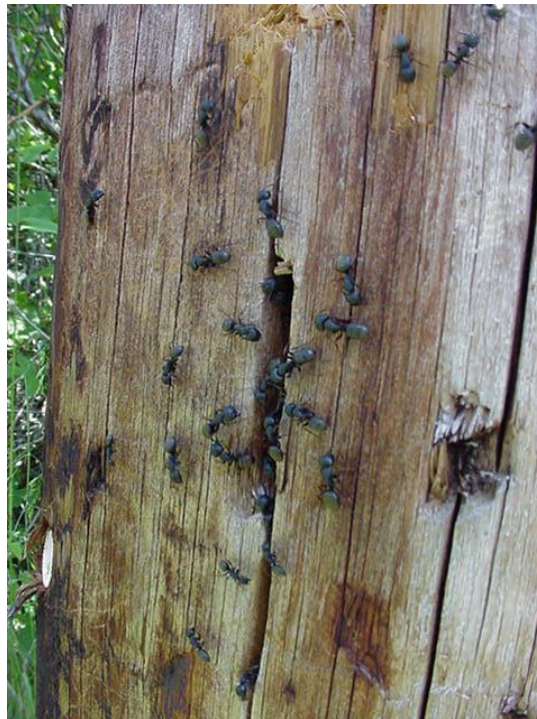
Photo 28

The third concern involves another insect that is known to have an overwhelming appetite for termites. These inexorable conquerors are **Carpenter ants**. (photo 28) If they detect termites in a pole, they will launch a well-organised attack that can result in further damage to a pole. It has been observed that ants will often establish a nest directly above a termite colony. From this point, they will devour the termites and any other insects nearby.

When attempting to assess the extent of damage caused by carpenter ants it is helpful to keep in mind that: the larger the ant, the older the nest, likely, the more severe the internal damage. Sawdust around the base of pole is a sure sign of carpenter ant activity.

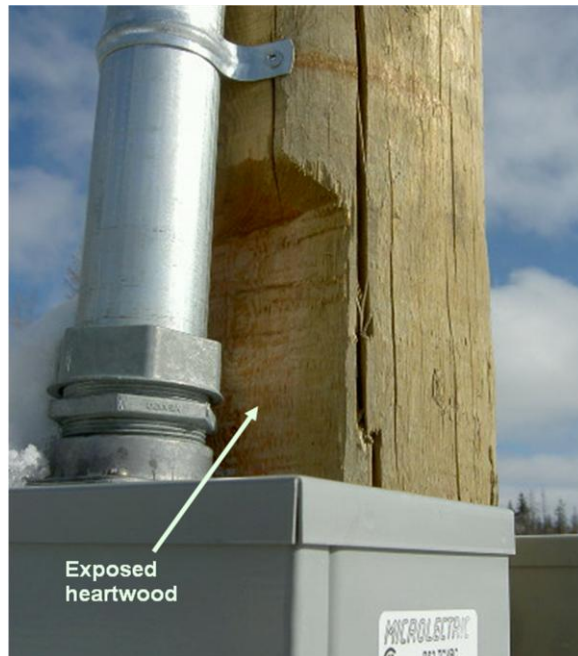
Photo 32

Example: A contractor cut deep notches into several pine poles in order to mount electrical service boxes for a business complex. (photo 32) The thoughtless actions of this individual seriously comprised the structural integrity and the service life of the poles. Photo 31 shows that the notches exposed untreated heartwood, thus leaving the poles open to attack by decay fungi or insects.
