## **ORGANISMS CAUSING DETERIORATION IN STRUCTURES**

**P. I. Morris**

**FPInnovations – Forintek Division, 2665 East Mall, Vancouver, BC V6T 1W5**

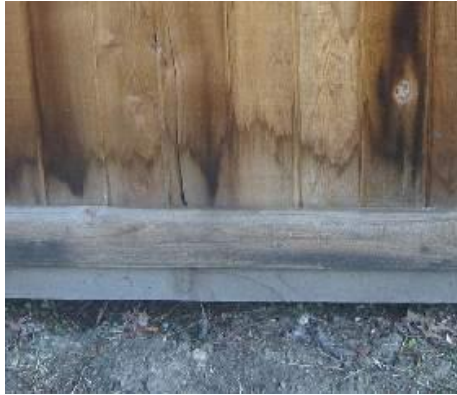
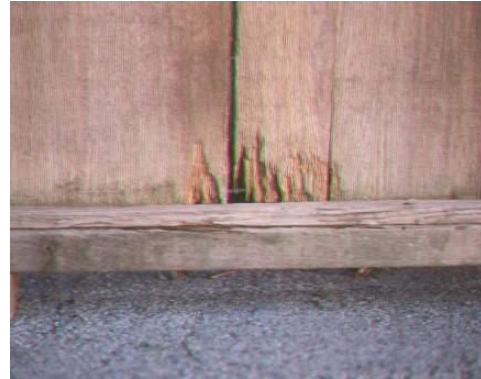
One of the most easily observable examples of dumb design is what I have come to call “the built to rot cedar fence” (Figure 1). Everybody will have seen this. The bottom of the fence is a 2 x 4 on the flat. Two nominal 1 x 1 inch strips are nailed or stapled at each edge leaving a slot into which the fence boards are dropped. A similar structure at the top holds them in place, at least until they start to get shorter. The reason they get shorter is that the eavestrough design of the bottom traps water, which wicks up the end grain taking the wood extractives with it. Deposition of extractives can be seen as a wavy dark band where the water evaporates. Low extractive content and moist conditions lead to decay at the bottom so when the board gets short enough it flops out of its frame. No wonder people consider using other materials reputed to be more durable. Designing these fences so they don’t trap water would substantially increase their service life and perhaps maintain this market.

Figure 1. The Built-to-Rot Cedar Fence

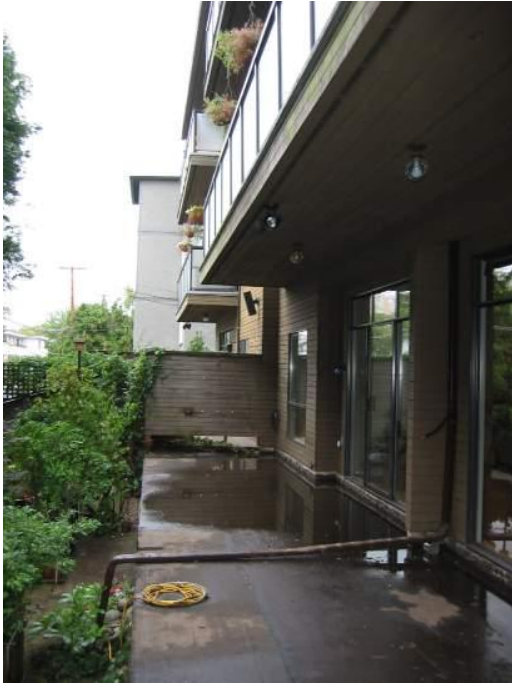
An example of dumb design that has affected me personally is discharging downpipes that have collected water from large pitched roofs onto small areas of slab, flat roof, or balcony, and expecting the water to find its own way to drain. Even worse is when the area slopes towards the building which was the case on the building where I live (Figure 2). The cedar deck on top of the slab was sitting in water for 9 months of the year. During the winter, warmth from the underground parkade would evaporate some of that water which would then condense on the underside of the deck boards. As a consequence the part of my cedar deck next to the building, where it was under the overhang of a balcony, unexpectedly rotted out faster than the part exposed to rain. That had me puzzled for quite a while. We have now put a sloped topping on the slab and run connections from the downpipe under the deck to the garden. Doing those simple things when the building was built would have saved a lot of money in repairs.

Figure 2. Slab Sloping Towards Building

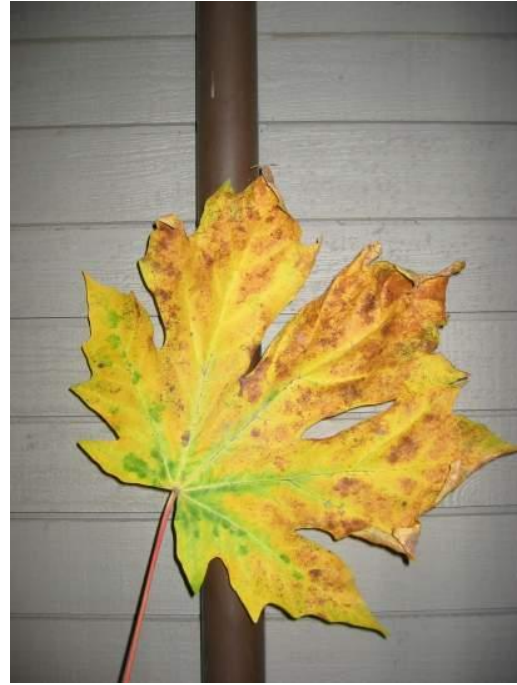
As another related example, our building downpipes were only 50 mm diameter and they were always getting plugged up with leaves. In coastal BC, we have a tree called the big leaf maple, which can have leaves 300 mm in diameter (Figure 3). We have now upsized those downpipes but it could not have cost a lot more to have put in the larger diameter in the first place.

Figure 3. Small Pipes and Big Leaf Maples

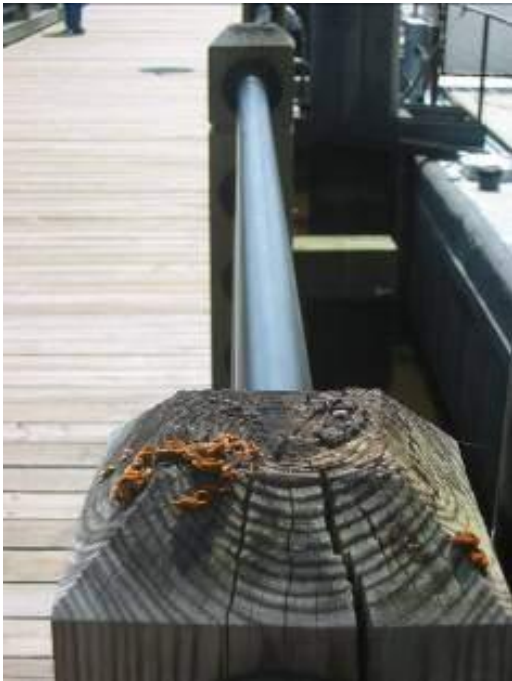
Inadequate penetration shows up a whole lot faster in southern climates. The American Wood Protection Association technical meeting in September 2009 was held in Wilmington, North Carolina. Along the river front, many of the CCA treated southern pine bollards on a boardwalk constructed only 3 years earlier (according to two locals) were showing fruitbodies of *Gleophyllum sepiarium* (Figure 4). That fungus does not grow well on heartwood so it seems likely that there was unpenetrated sapwood in this material. It really should be possible to fully penetrate the sapwood of southern pine.

Figure 4. Fruitbodies of *Gleophyllum sepiarium* on CCA Treated Southern pine after 3 Years

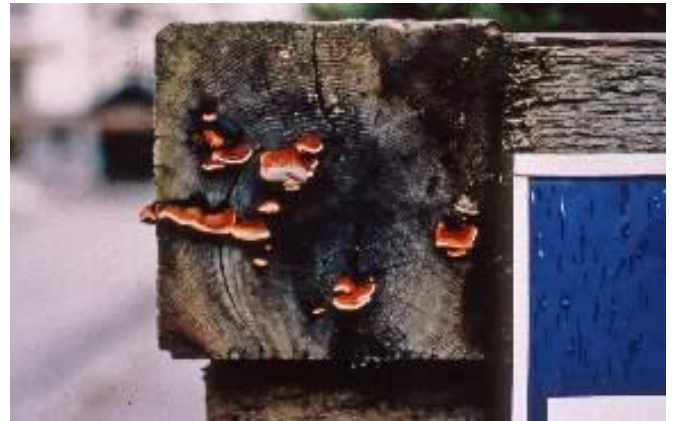
dimension products, this may be a limited enough area that the amount of mobile copper available on adjacent treated surfaces can provide protection (Choi et al 2004, Morris et al 2004). On 4 x 4s and larger sizes, cross cut ends will decay if not protected with a field-cut preservative. Failures of cut landscape timbers have been noted within 8 years in Vancouver and Whistler (Figure 5). Unfortunately field-cut treatments are rarely applied. That is mainly because the producers of wood preservatives and treated wood and the retailers do not do enough to educate consumers about the need for such treatment. It is also partly because copper-naphthenate is unpleasant to work with and difficult to clean up. Work is underway at FPInnovations to evaluate alternative water-borne field cut preservatives. Ideally these would be placed in the treated wood aisle in the big box stores and not next to the deck cleaners.

Figure 5 Cut Ends Without Field-cut Preservative Decaying in 8 Years in Whistler BC
