# OBSERVATIONS ON PLASTIC LUMBER AS A SUBSTITUTE FOR PRESERVATIVE-TREATED WOOD

P.I. Morris
Forintek Canada Corp.
2665 East Mall,
Vancouver, B.C.
V6T 1W5

# Observations on Plastic Lumber Products in Everglades National Park

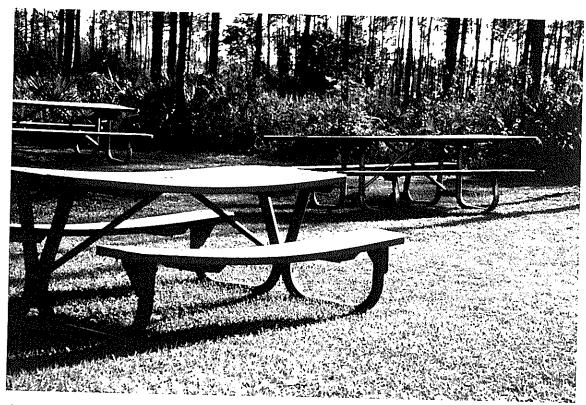
Recycled plastic products (without wood fibre) are well known to require wood or metal substructures to provide stiffness and load-carrying capacity (Figures 2, and 3). Without such support these materials can barely hold up their own weight (Figure 1). Even plastic/wood composites, deck joists (typically preservative-treated wood) may have to be as close as 30 cm (one foot) on centre (Figure 4). The deck boards must be predrilled and screwed rather than nailed.

Figure 1 Sagging recycled-plastic-lumber picnic table. The level tables in the background are pressure-treated wood.

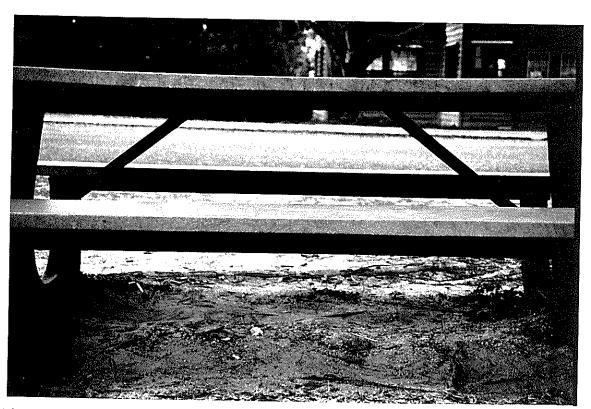
Figure 2 Metal-supported recycled-plastic-lumber picnic table

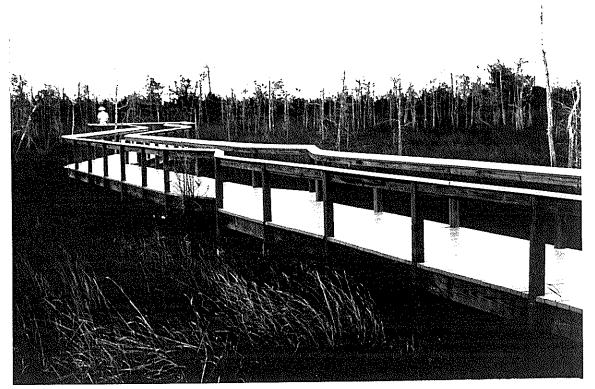
Figure 3 Wood-supported recycled-plastic-lumber walkway

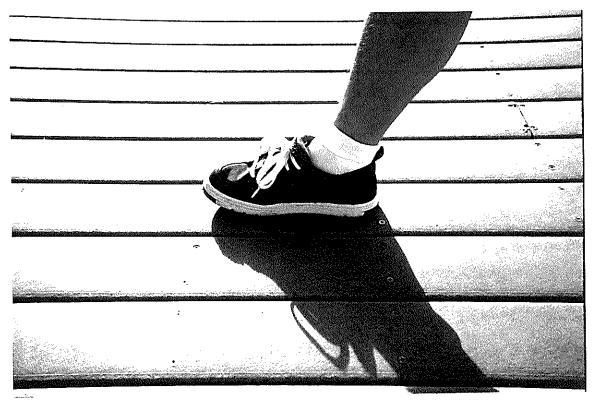
Figure 4 Joists 1 foot on centre - plastic/wood composite lumber

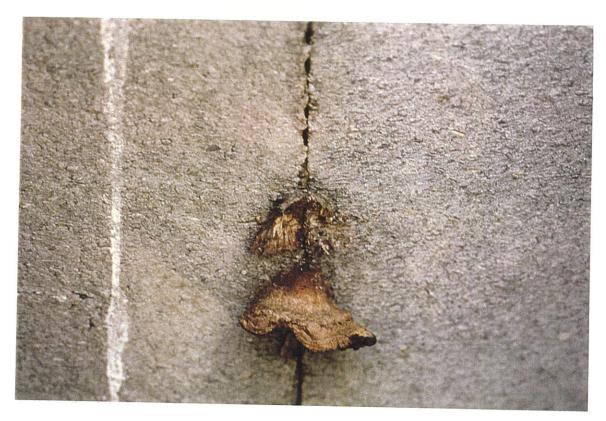
While these strength issues were anticipated, the observation of wood-rotting fungi growing on this material (Morris and Cooper 1998) came as something of a surprise. One fungus was Gloeophyllum striatum (Swartz:Fr.) Murrill (Figure 5), a brown-rot fungus (Gilbertson and Ryvarden 1986), and the other was Pycnoporus sanguineus (L:Fr.) Murrill (Figure 6), a white-rot fungus (Nobles and Frew 1962). Furthermore dark stained patches on the surface of the plastic/wood composite (Figure 7) had the appearance of fungal stain. Microscopic examination confirmed extensive colonisation by a blue-stain fungus (Morris and Cooper 1998). Considering these findings, it is highly likely that, this material would also be susceptible to soft rot in ground contact. Soft rot is caused by

The product in question was a 50:50 mixture of wood fibre, mostly hardwood, and recycled high-density polyethylene (Shaw 1997, Morris and Cooper 1998). The conditions were probably right for decay in much of this material. Swelling due to absorption of moisture was indicated by horizontal bowing of many boards which were restrained at both ends (Figure 8). Given this dimensional change and the growth of wood-inhabiting fungi on this material, it would appear that the wood fibres were not completely encapsulated by plastic.

Figure 5 G. striatum on plastic/wood composite lumber

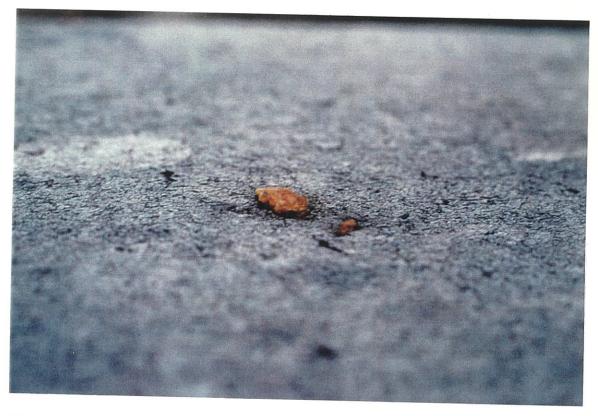
Figure 6 P. sanguineus on plastic/wood composite lumber

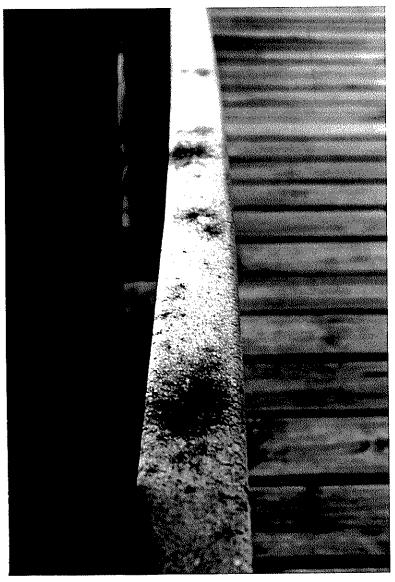
Figure 7 Bluestain on the surface of plastic/wood composite lumber

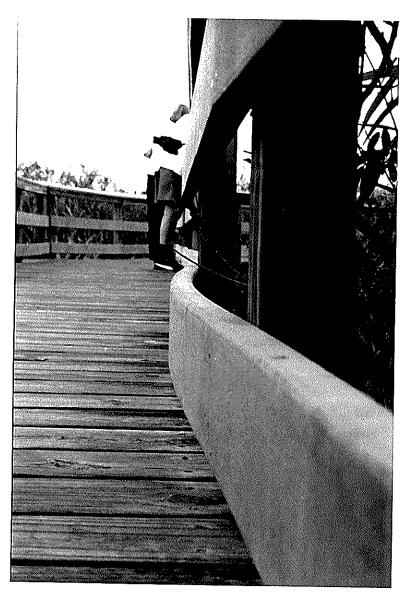
Figure 8 Bowed horizontal boards of plastic/wood composite lumber
