PRETREATMENT INFECTION AND PREMATURE FAILURE
OF PCP-TREATED SOUTHERN PINE
POLES

P.I. Morris and
Research Scientist
Forintek Canada Corp.
Western Laboratory
Vancouver, B.C.

B.J. McAfee
Research Scientist
Forintek Canada Corp.
Eastern Laboratory
Ottawa, Ontario

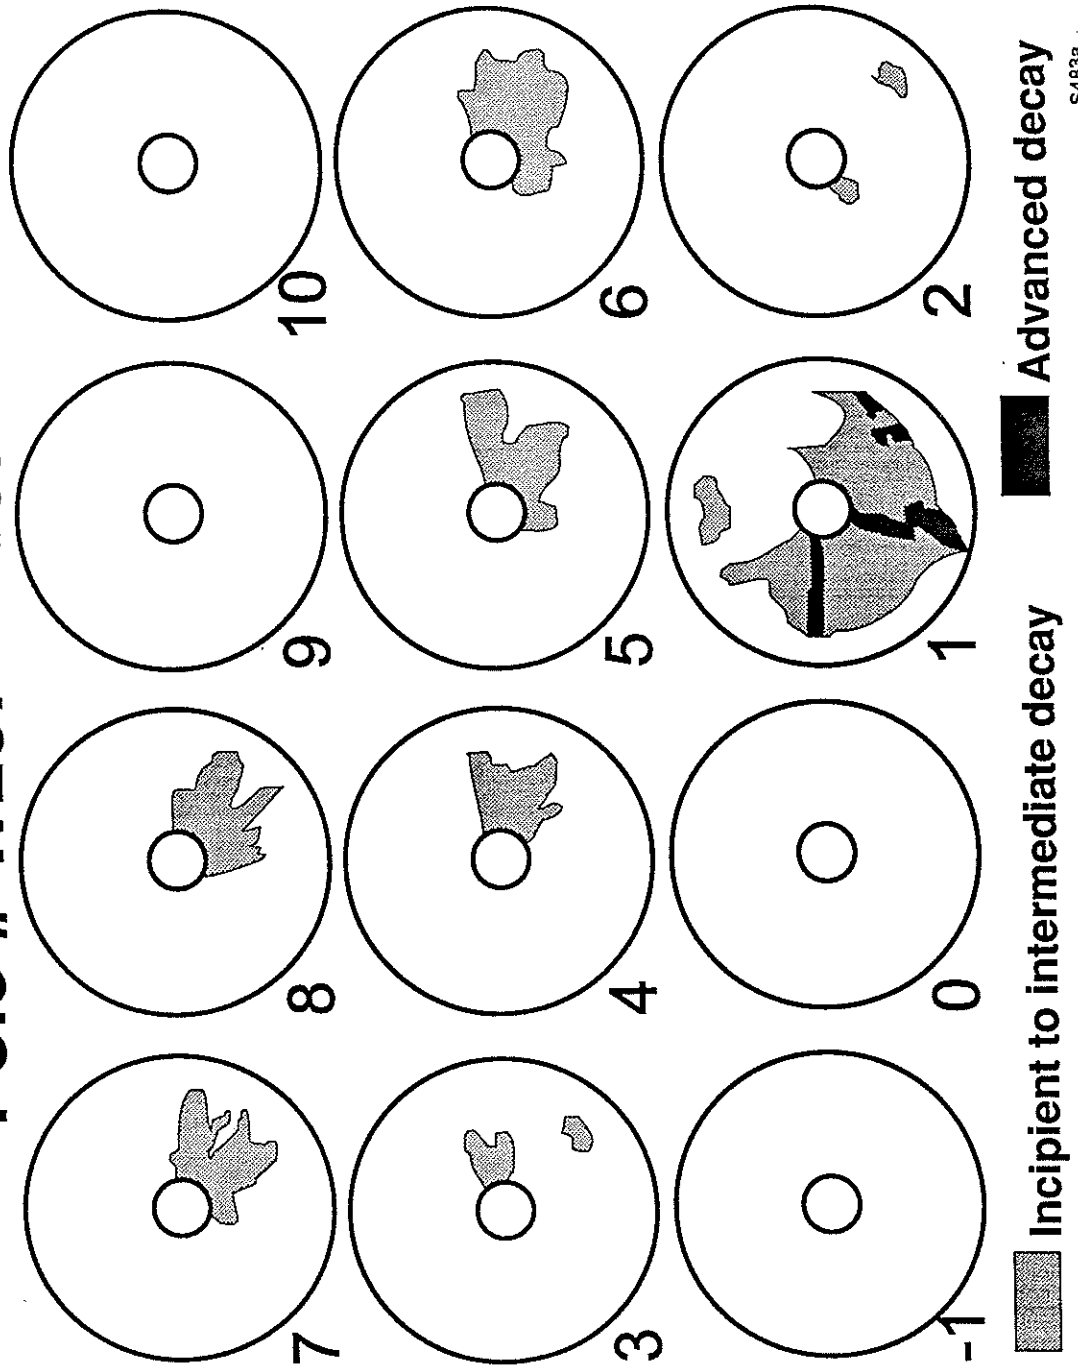
FIGURE 2

In ten of the twelve poles with intermediate or advanced decay which were intensively examined, the greatest damage had occurred in the middle of the length of the pole (Figures 2 and 3). This section would be the last to dry out in the wide sapwood southern pine species, since drying through the end grain can be 1000 to 10000 times faster than through the sides. Similarly, where the decay was less extensive it was commonly confined to the inner sapwood, the last part of the cross section to dry out. Although inner sapwood decay can be caused by post treatment infection of a band of untreated sapwood via checks (24), this is extremely unlikely in such a wide sapwood treatable species. There was no evidence of checks developing after treatment penetrating the full depth of the sapwood and the decay patterns were not associated with checks.

The patterns of decay were related to the pattern of infection and colonisation of poles by fungi during air seasoning. This was most discernable where the decay had not progressed too far. Here the decay pattern consisted of a collection of roughly wedge shaped segments radiating out from the heartwood (Figure 2). In most cases the decay did not reach

Extent of Decay in Pole #W237 Over Cross Sections at 1 m Intervals
