THE USE OF TREATED WOOD IN THE RESTORATION OF RESIDENTIAL BUILDINGS IN SOUTHWESTERN BRITISH COLUMBIA

Henry Touwslager

Marsh Touwslager Engineering

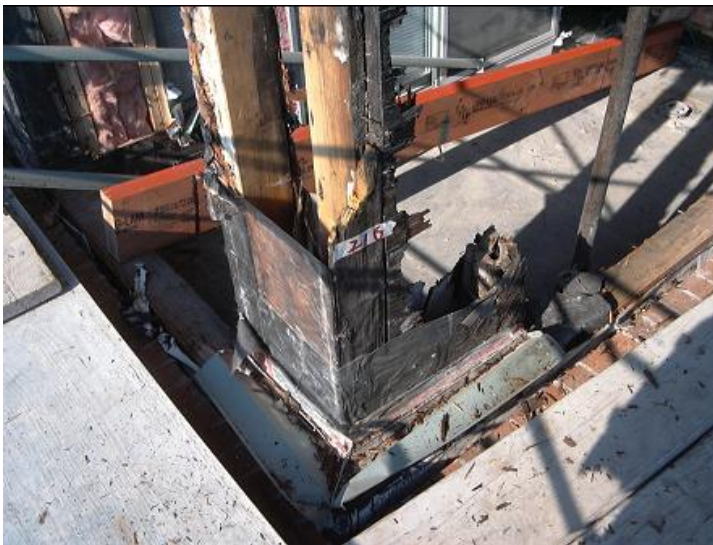
Photograph 1: Decayed balcony column.

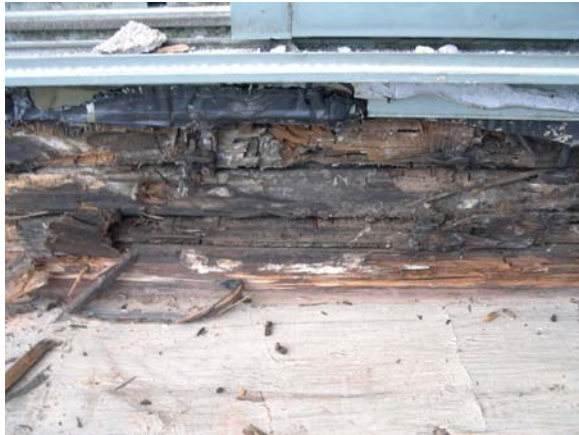
Photograph 2: Decayed sill plate.

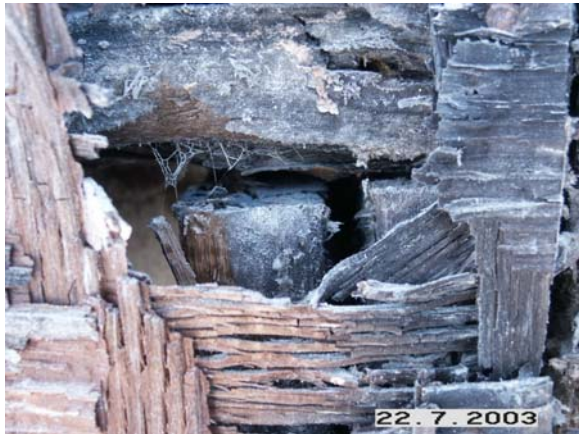
During demolition, the sheathing is examined to ensure it warrants replacement. The consultant must also consider the purpose of the sheathing and whether the wall was intended as a shear wall. A pick test or scratch test is required to determine if the strength loss of the plywood is significant enough to warrant replacement. It is a good idea to test the sheathing in several areas to “calibrate” your awl before assessing all the wood on the site. Dimensional lumber also requires a pick test to determine the structural strength. In most cases, the discolouration of the wood is enough to indicate strength loss. Sometimes the plywood or structural members are so badly decayed that the awl is not required and the material can be removed with finger pressure or it simply crumbles away.

Photograph 3: Decayed plywood.

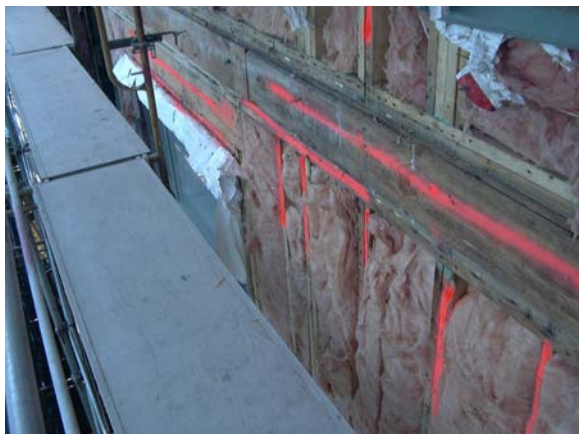
A project manual is prepared that provides details and drawings indicating which materials have to be replaced. Plywood is typically shown as a new material with the assumption that all the original Oriented Strand Board (OSB) or plywood will be removed and discarded. During construction, a visual review is completed and an effort is made to retain the undamaged sheathing, particularly in covered areas. Studs and other framing members are shown in the tender documents as materials to be retained. After a visual review during construction, the decayed members are marked by the consultant for replacement.

Photograph 4: Wood framing marked for replacement.

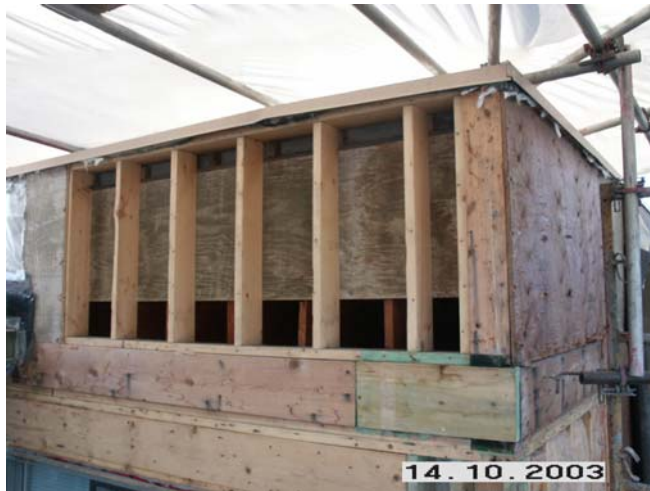
Photograph 5: Replaced wood framing. Treated wood is visible.

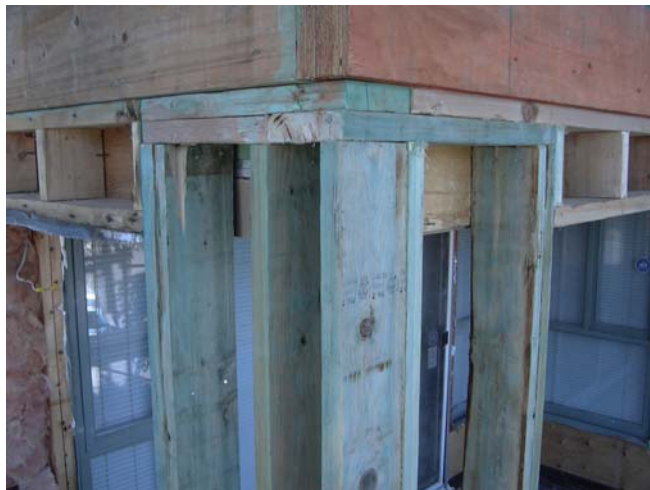
Photograph 6: New wood framing at the balcony column.

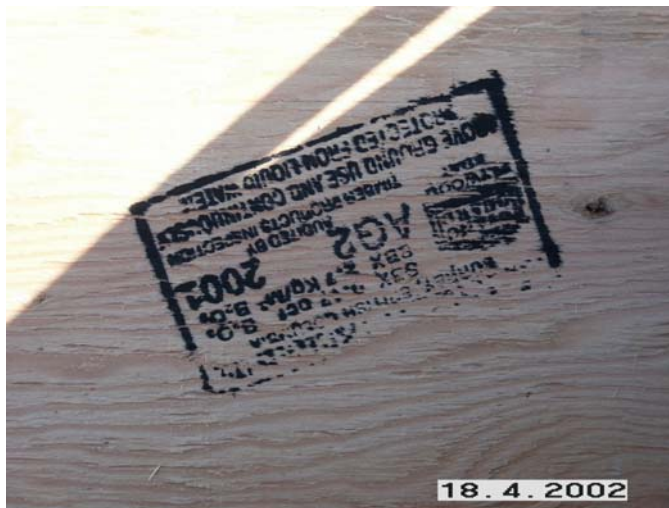
All treated materials should be verified for conformance with the specifications before being installed on the building. Occasionally, the materials delivered to the site are not what was specified or ordered. Verification can be completed by reviewing the treatment stamps found on most treated products. Where a stamp exists, verification is quite quick and easy. Where there is no stamp, verification is much more difficult as you have no way of knowing the level of treatment that was provided. Sometimes the material delivered is not only missing the treatment stamp but is also the wrong species of wood.

Photograph 7: Preservative treatment stamp.
