Protection of Industrial Wood Products with ACZA

Tim Carey, Product Manager, Industrial Business
Lonza Wood Protection
Atlanta, GA

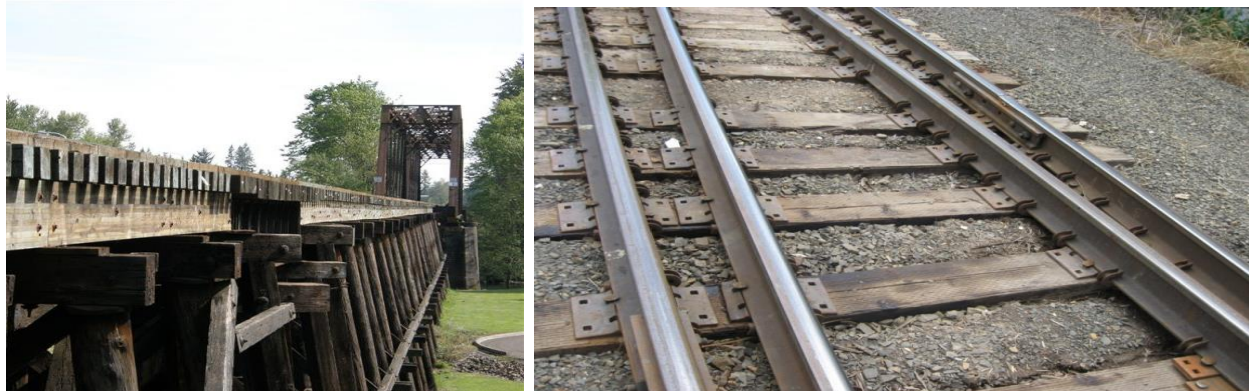
Since the 2013 presentation We have visited the sites where we have ACZA and ACZA +DOT ties. Including one of the first bridges of ACZA Douglas fir bridge ties and laminated timbers in Oregon. After 8+ years the bridge showed no signs of degradations nor exceptional checking even with an aqueous preservative treatment. The same is true with the 8+ year old ACZA Douglas fir crossties and switch ties in Oregon. As seen in Figures 1 and 2 below.

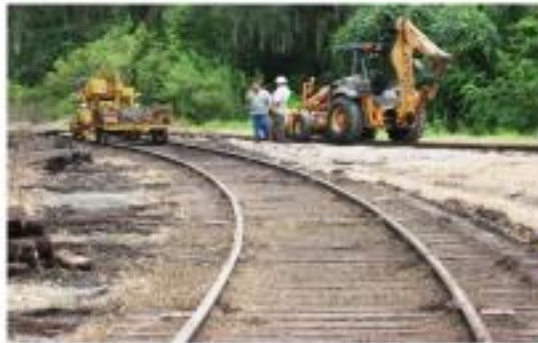
SW Florida hazard zone 5+ _

The ties in SW Florida were installed in a “Y” Curve where not only are they getting typical pounding but also lateral stresses from the curve. The lack of ballast continued to show the ties being submerged into the area swamp. Some of the ties had been cut with by a derailment. This section of track has a seven-year life span for its hardwood creosote ties and they were pleased that after 5 years, the ACZA sand ACZA +Borate ties were holding up well.

- After evaluation the test ties at all three exposure sites it was noted that biological deterioration was not a problem at this time. All treatment and/or species combinations were showing excellent protection.
- Mechanical issues while not the focus of this research were the prevalent problems noted and none of these are attributed to the preservative treatments found in the test ties. Future inspections are planned for 2019/2020 to continue monitoring the efficacy of these test ties.
 - Michael Sanders, Senior Research Associate, Mississippi Forest Products Lab, Mississippi State University

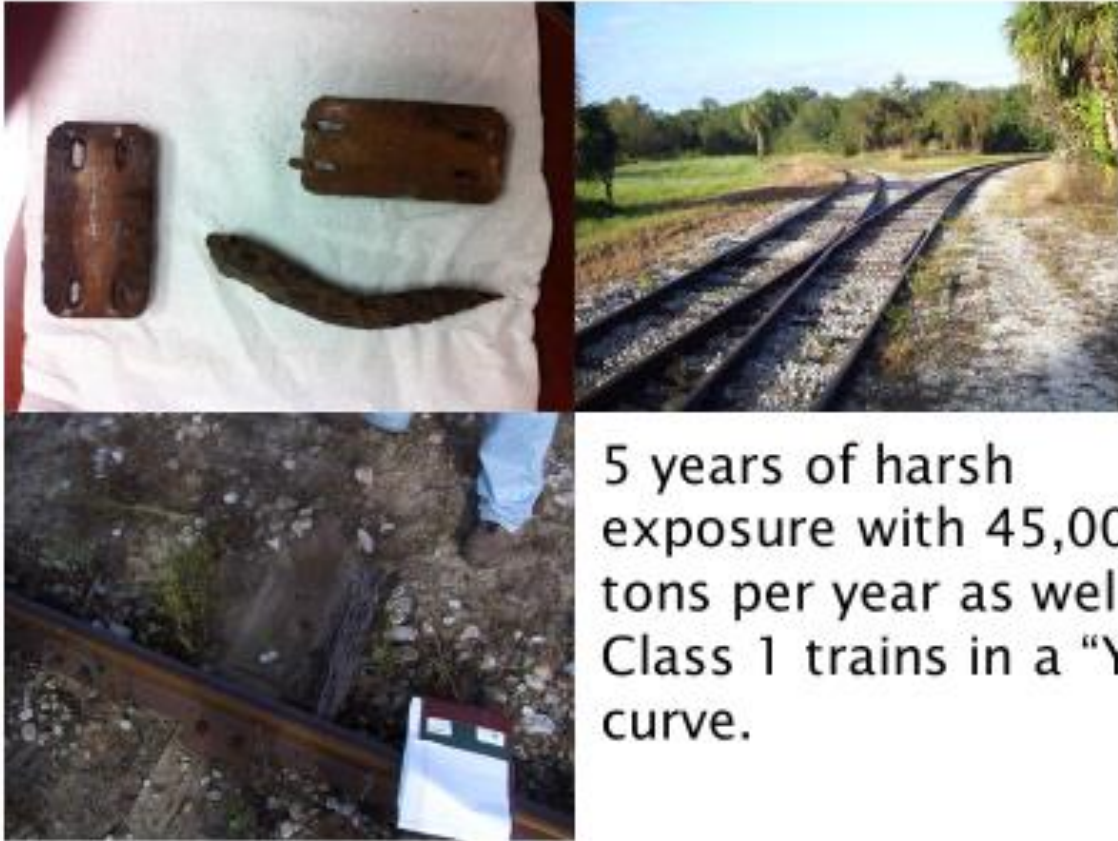
Figure 4 SW Florida Site:

December 2016 Southwest Florida Site

5 years of harsh exposure with 45,000+ tons per year as well as Class 1 trains in a “Y” curve.

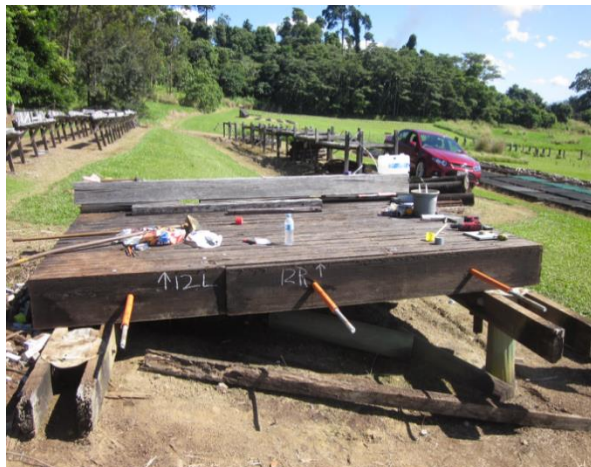
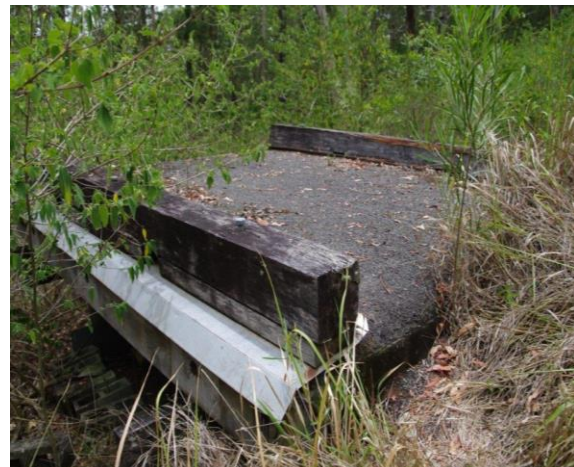
Figure 5 and 6 below shows the bridge at the test site and the working bridge at Mt. Mee.

- Results of treatment
- Penetration from 116 cores taken:
- Ave. 1.2" far exceeding the 0.4" required
- Only 4 cores had penetration of less than 0.4"
- No visible signs of decay on any of the boards
- Retention cores were taken from the upper edge surface of the boards only and were at 54.2% of the required retention
- The retention was above the threshold of 0.15 pcf

- The ACZA treated Douglas-fir in the stressed deck assemblies at both South Johnstone and Mt. Mee were both sound and free of visible decay.
- No decay fungi were isolated from the materials at South Johnstone while preservative retentions were lower on the upper deck surfaces, but well above the protective threshold after 20+ years of field exposure.
- The results illustrate the benefits of pre-fabrication coupled with proper treatment for producing long term performance under harsh environmental conditions.

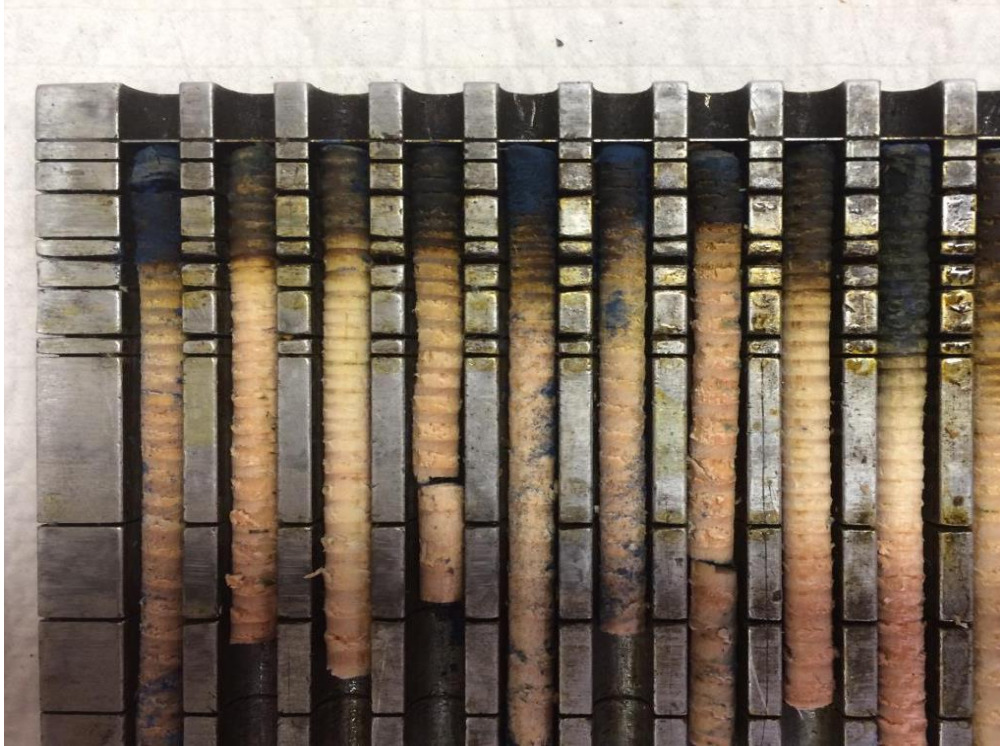
The poles were sampled as soon as they were cool enough to core, no extended time was used to allow for boron diffusion. Figure 7 below shows the copper penetration indicator used for ACZA. These poles were not incised, radial drilled or through bored due to their use on the obstacle course.

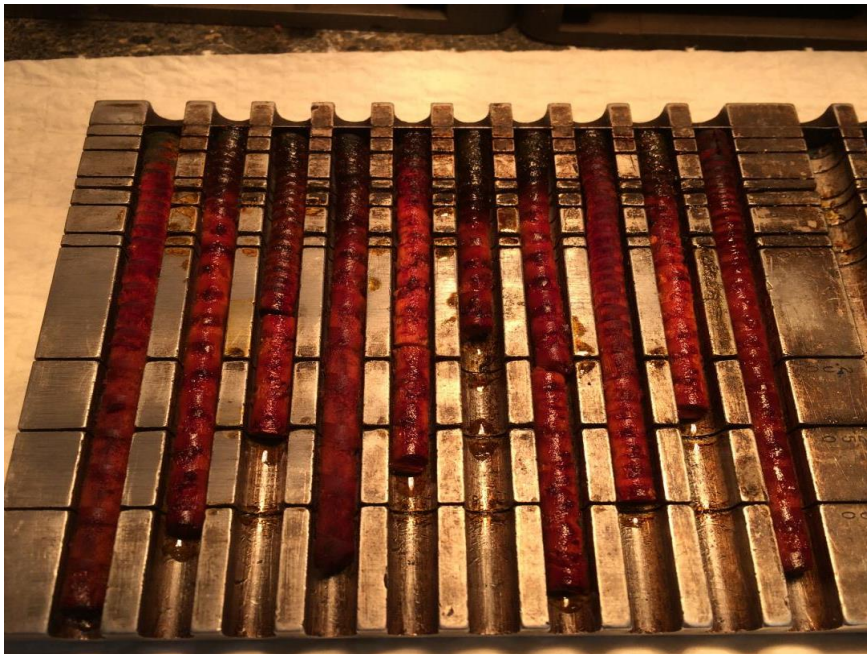
Figure 8 shows complete boron penetration with the use of boron indicator.

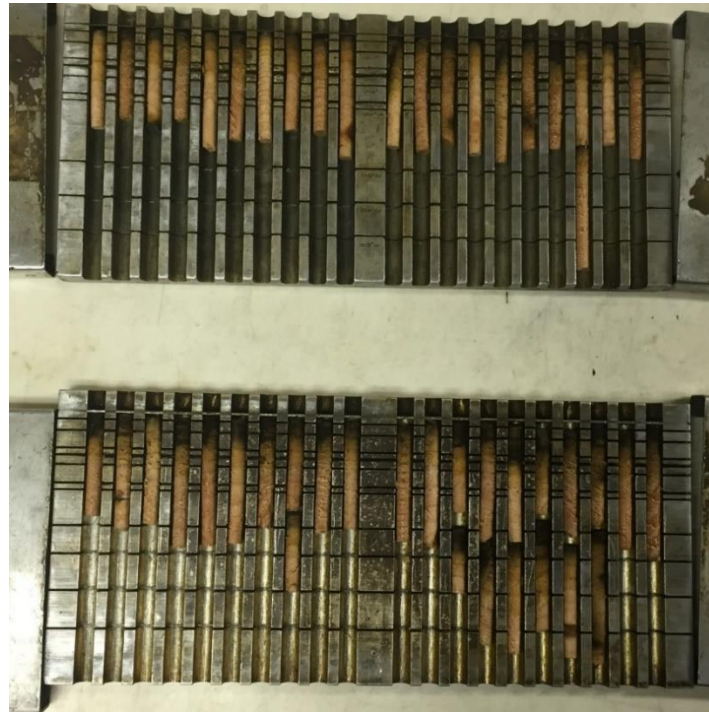
Figure 10 shows the variaiton in treatment between the incised and unicised areas of the posts.
