CANADIAN WOOD PRESERVATION ASSOCIATION

PROCEEDINGS

37th AGM

OCTOBER 18-19, 2016

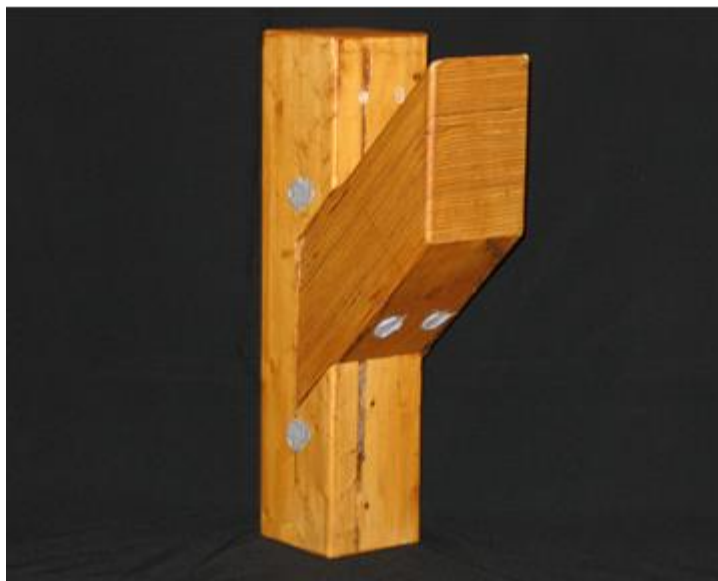
Figure 2 Borate/glycol-treated γ -joint showing copper/borate rod locations

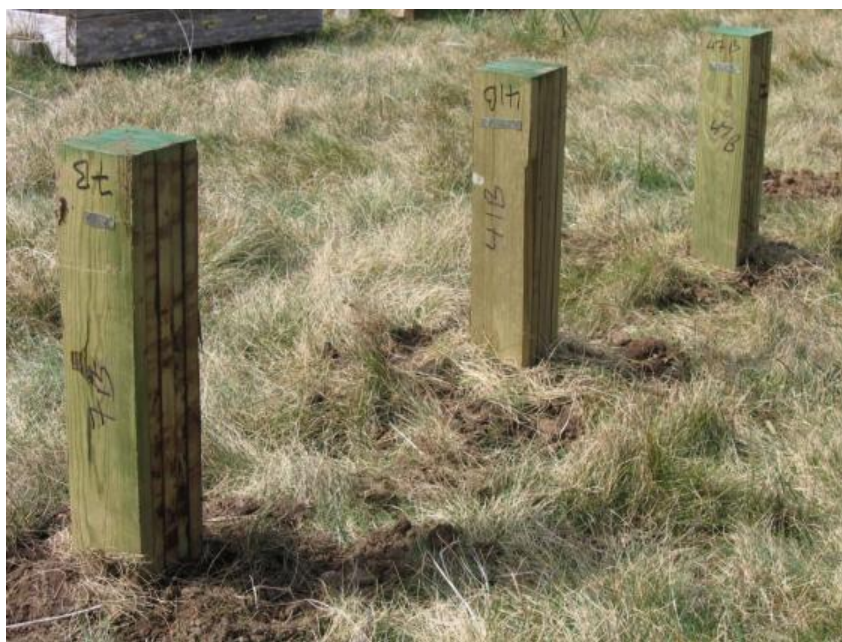
Figure 4 Glulam posts buried vertically to half depth in the ground

The glulam posts were installed at FPInnovations' test site at Maple Ridge, BC in April 2010, buried vertically to half their length (Figure 4), with samples representing the test variables randomly located among the four quadrants of this test site to offset variations in soil conditions within the Maple Ridge plot. Post holes were pre-drilled using a six-inch diameter powered auger and a sample layout map was prepared.

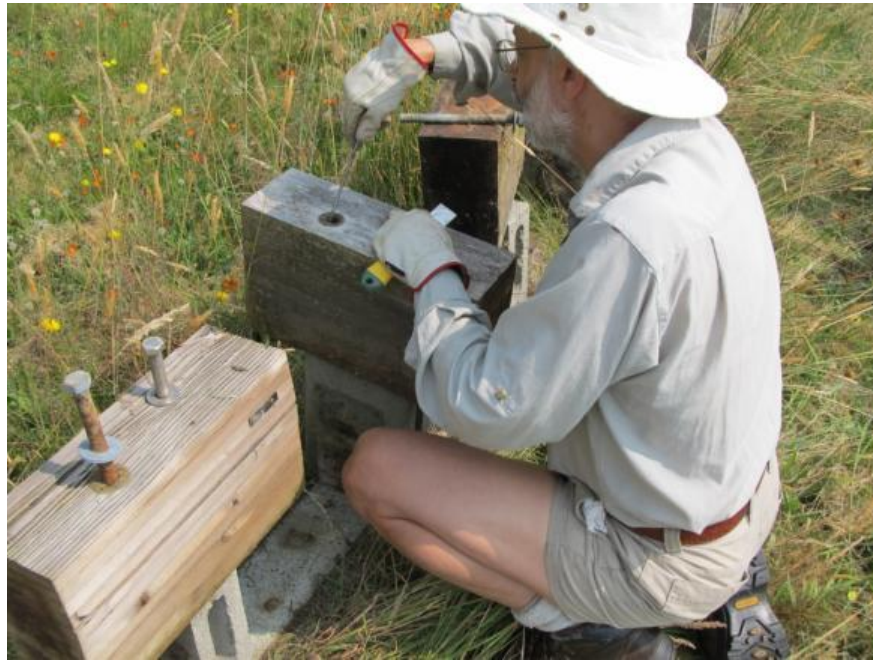
Figure 6 Inspecting above-ground beams

After five years of exposure, each above-ground beam was removed from the masonry block, examined visually for indications of decay, as described above, and assigned a decay rating at six locations: on the top surface, bottom surface, the end closest to the stainless steel bolt, the end closest to the galvanized bolt, and inside each of the two bolt holes. A screwdriver specially adapted with a bent end was used to probe inside the bolt holes for softness associated with decay (Figure 6).

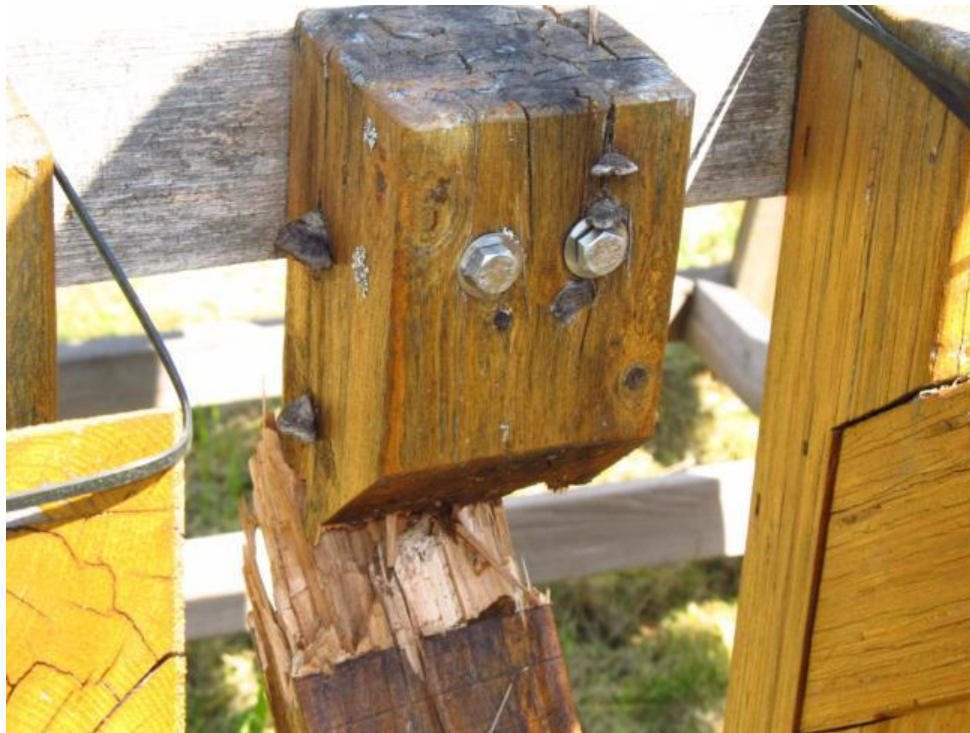
Figure 7 Failure of untreated black spruce glulam unit at six years of exposure

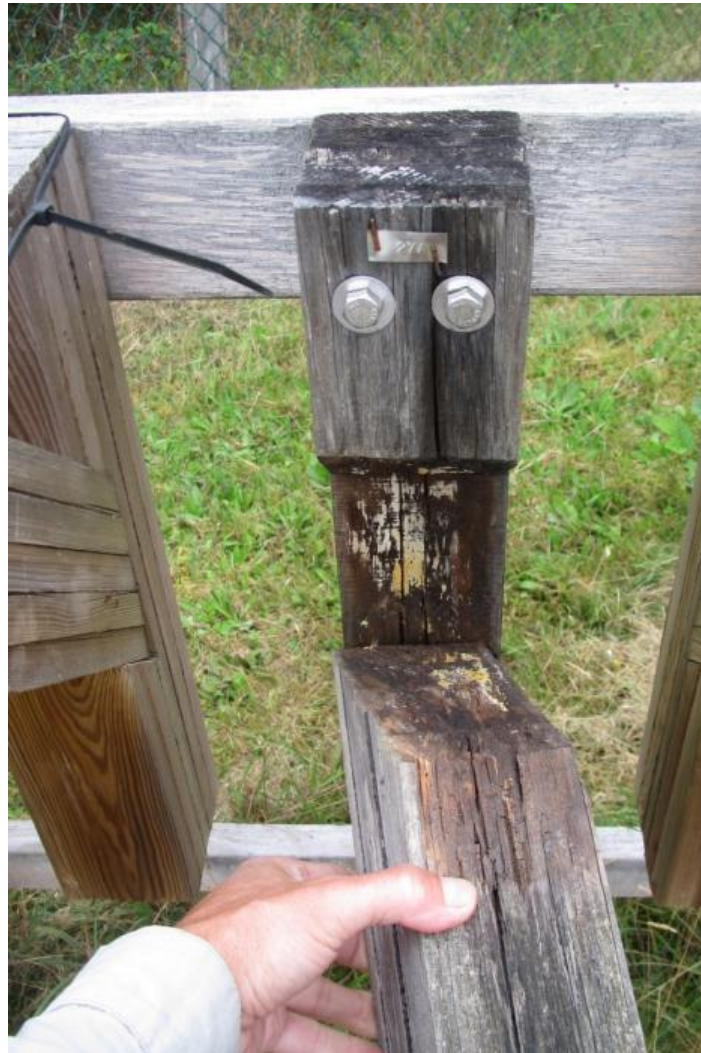
Figure 8 Decay after six years in untreated glulam γ -joint installed above ground

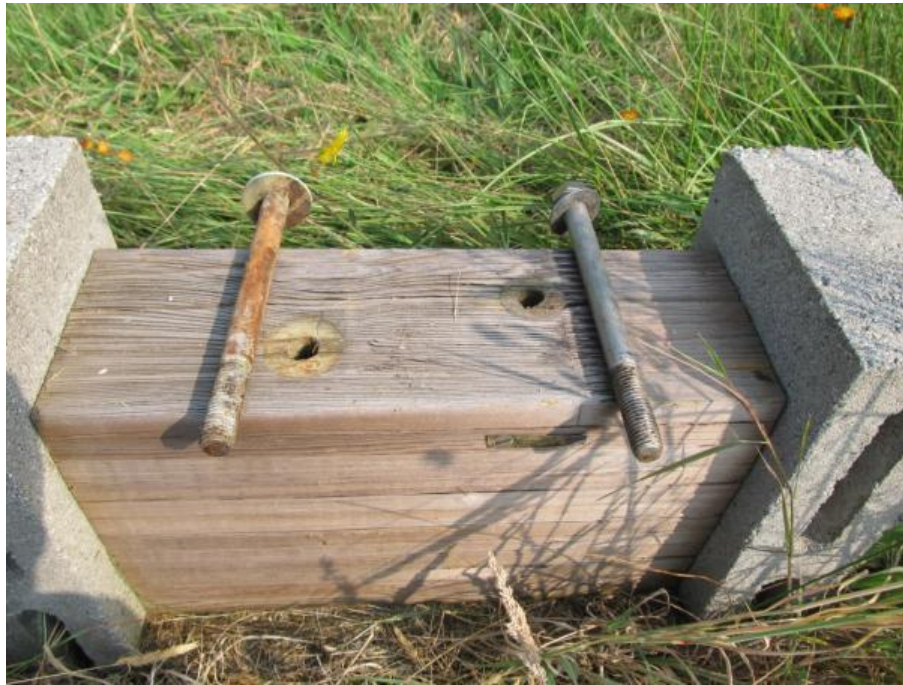
Figure 9 Rust on galvanized bolt in an ACQ-treated sample

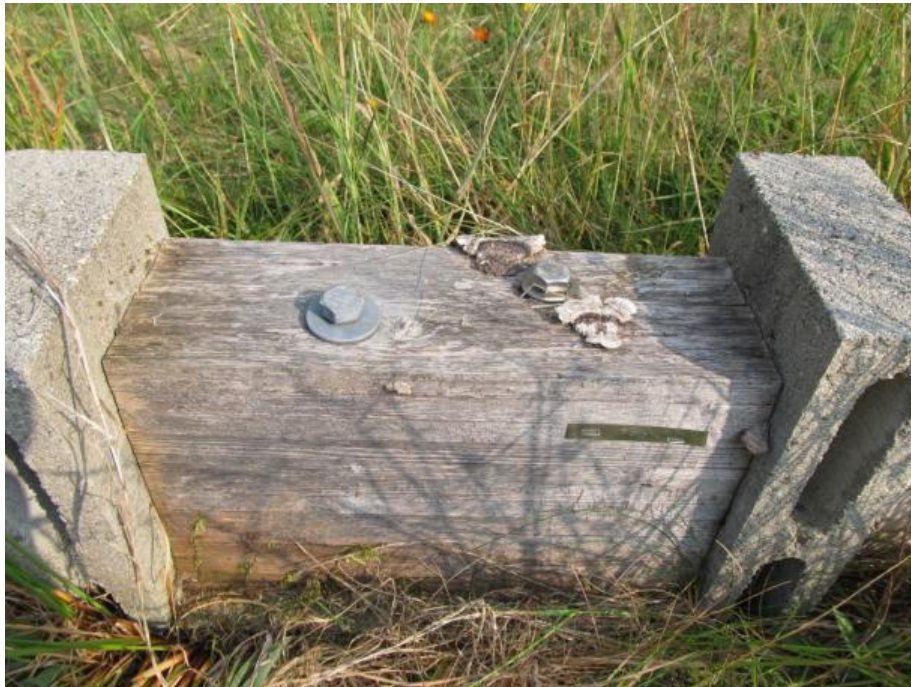
Figure 10 Fruitbodies of *Gloeophyllum sepiarium* on the top surface of an untreated Pacific silver fir glulam beam close to the stainless steel bolt.

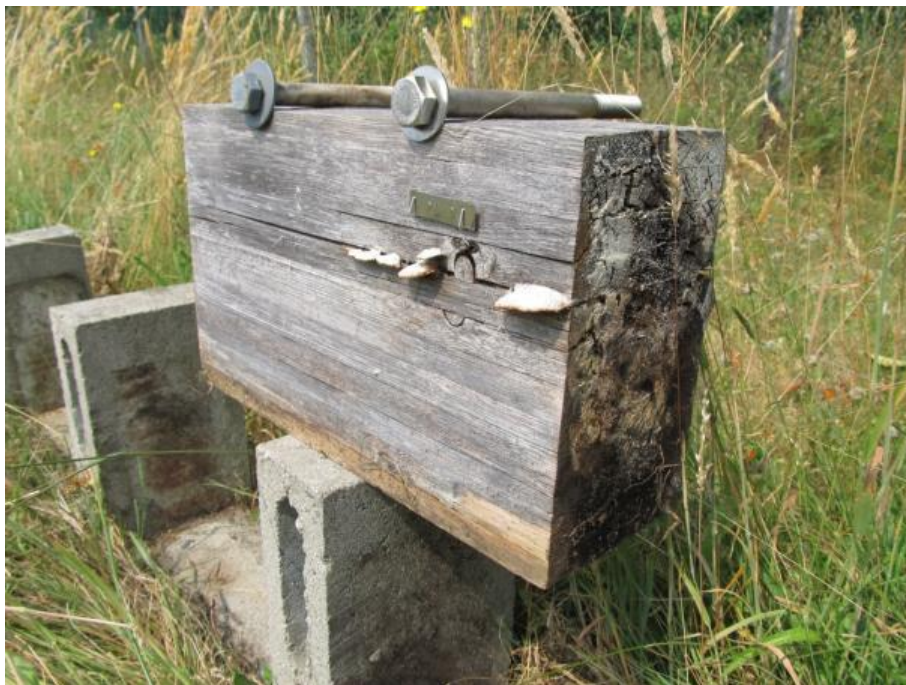
Figure 11 Fruitbodies of *Gloeophyllum sepiarium* towards the end of an untreated lodgepole pine beam with the stainless steel bolt

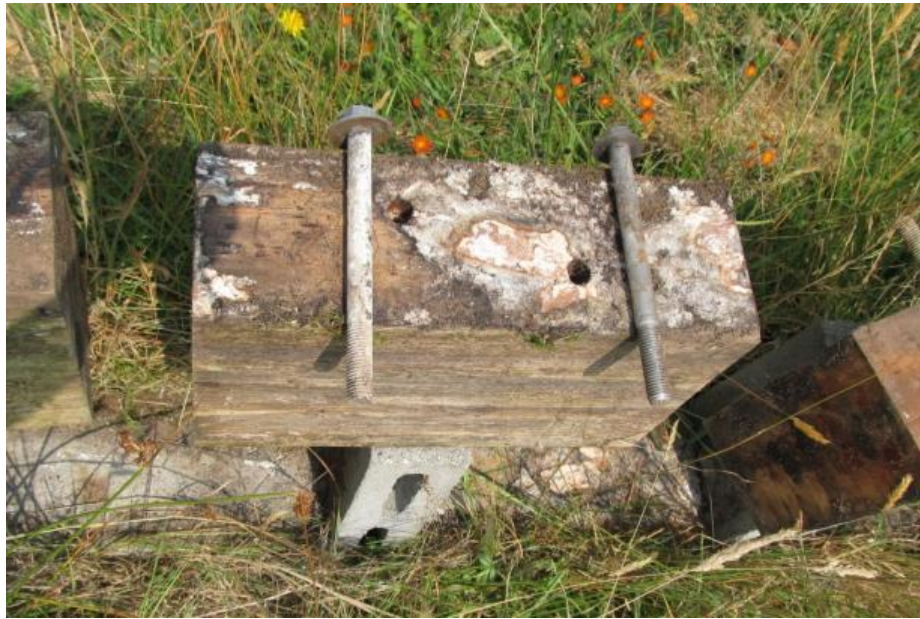
Figure 12 More extensive mycelial growth on the underside of an untreated Pacific silver fir glulam beam at the end with the stainless steel bolt.

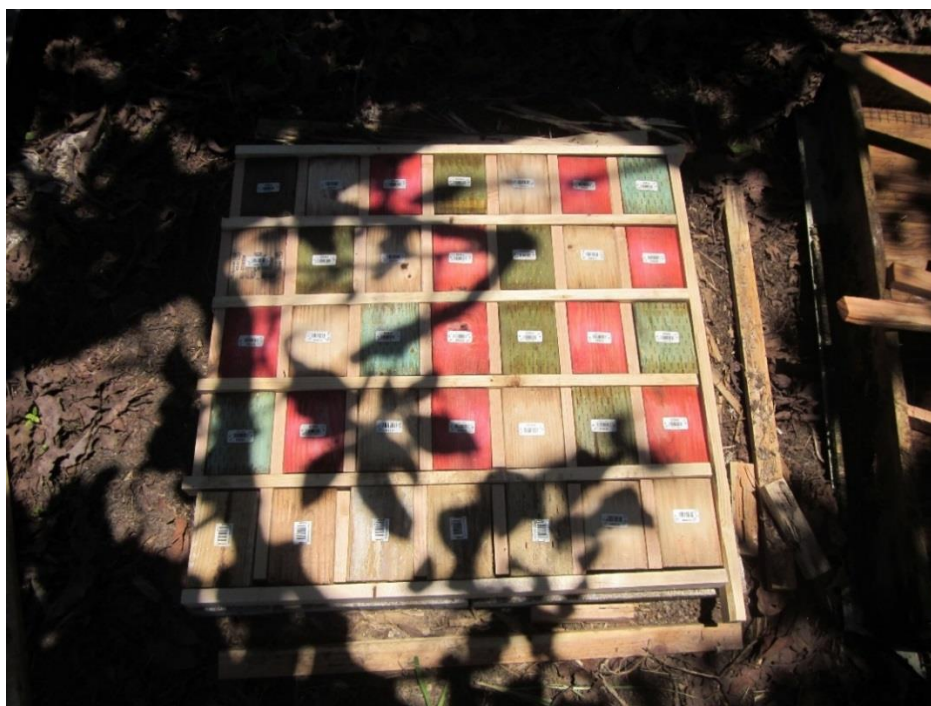
Figure 1. Example of a termite array with samples treated with Eco Red Shield II, HiBor or left untreated in the E26 Ground Proximity termite test after installation in June 2015.

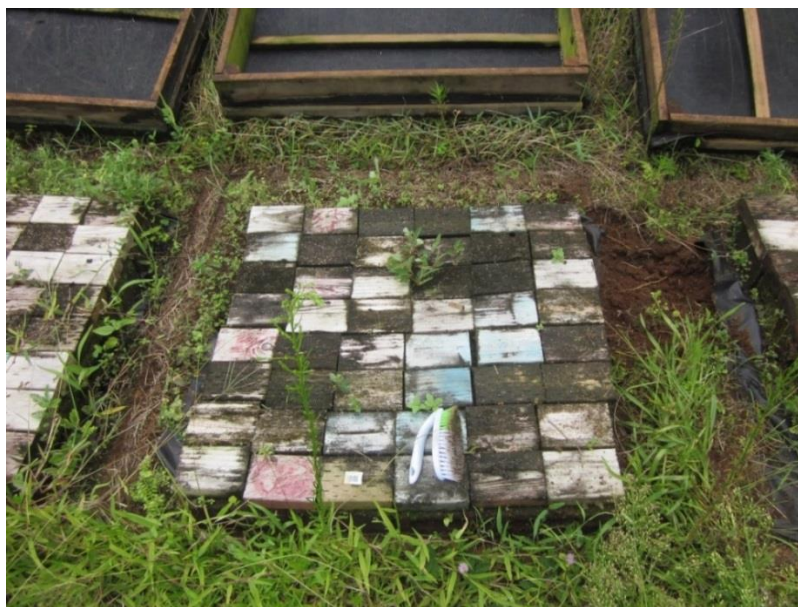
Figure 2. Example of an E18 Ground proximity decay test prior to the 18-month assessment after removal of vegetation showing heavy algal growth on the upper surfaces.

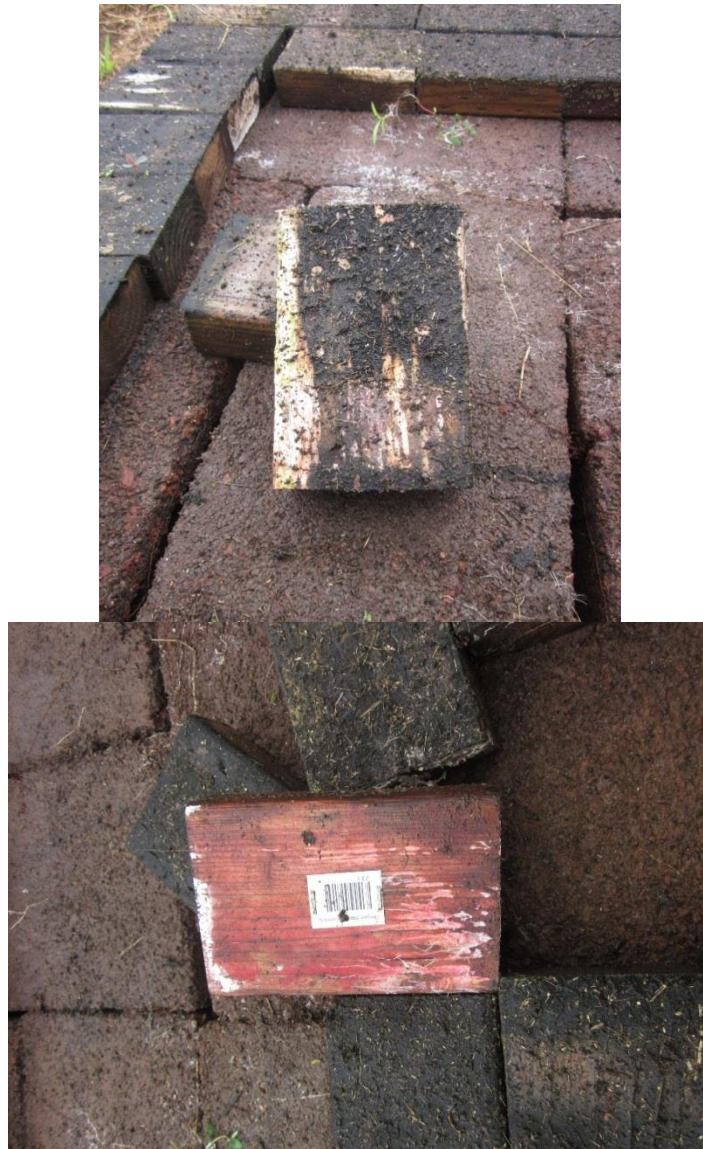
Figure 3. Examples of a non-treated control (left) showing extensive surface growth and slight decay and an Eco Red Shield I sample showing white fungal growth and decay.

The Eco Red Shield I, BluWood, and Timbersil samples have begun to experience decay on the lower surfaces (Figures 3) and had ratings that were slightly lower than those for the non-treated controls, although the degree of decay remains small. These results suggest that the performance of the alternative treatments is not markedly different from the non-treated control. The copper azole treated samples were all free of visible decay (Figure 4).

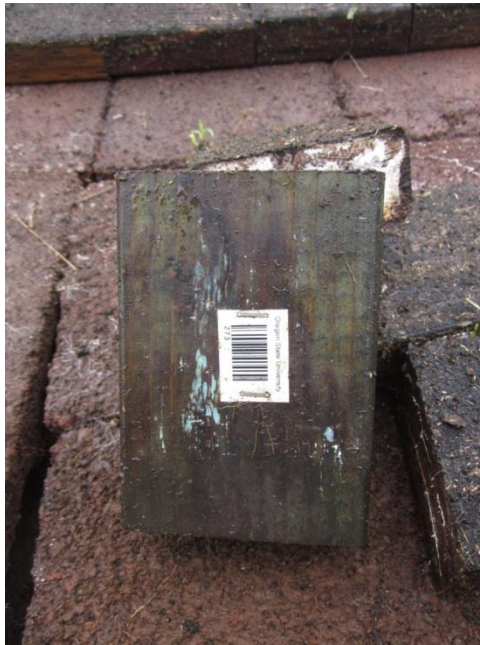
Figure 4. Example of a BluWood ground proximity sample after 24 months of exposure showing decay pockets with concentrations of the original blue dye used to color the wood.

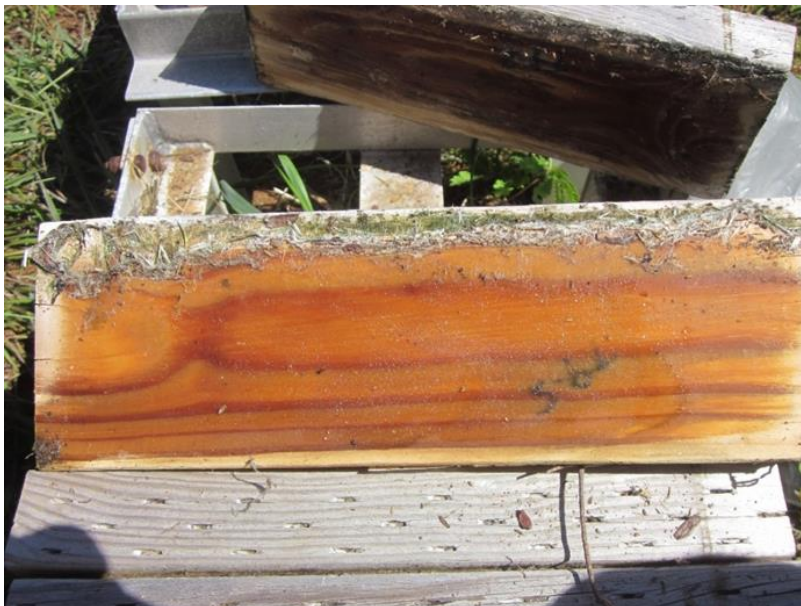
Figure 5. Example of a Timbersil treated sample from a sandwich test showing the collection of wood fibers on the upper, UV exposed surface.

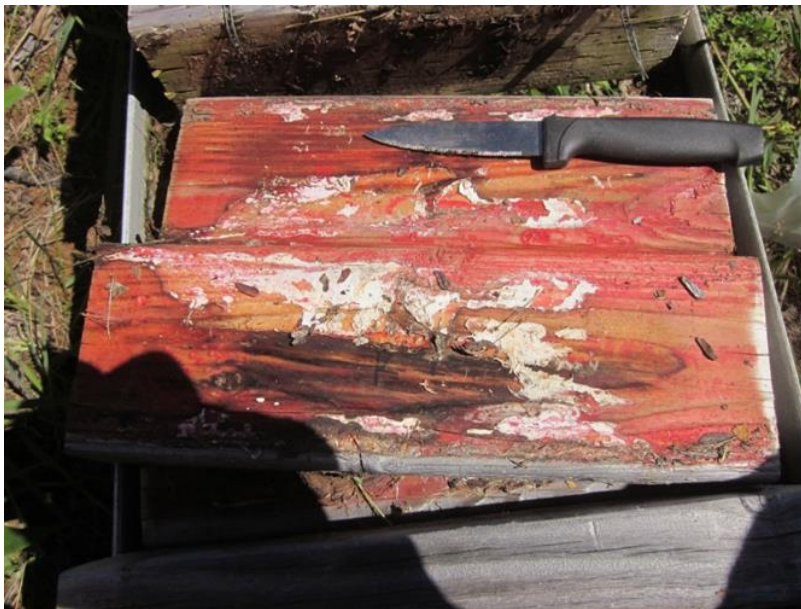
Figure 6. Example of the center sample of an Eco Red Shield I treated sample after 18 months of exposure in the sandwich test showing surface decay.

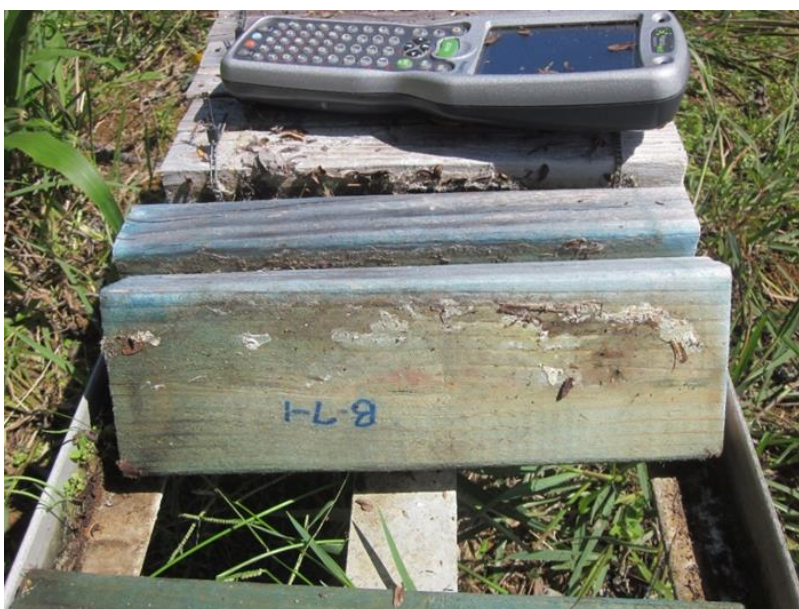
Figure 7. Example of the middle sample of a BluWood sandwich showing white fungal mycelium and slight surface decay after 18 months of exposure.

The Eco Red Shield I treated samples had a slightly lower rating than either the controls or the other treated samples at 18 months; however, virtually every middle sample in the sandwiches treated with this system had evidence of fungal mycelium and decay (Figure 6). While this attack had not yet progressed to an advanced stage, the samples had pockets of bleaching and fungal mycelium on the surfaces between the sandwich pieces. These results suggest the Eco Red Shield I material has begun to experience active fungal attack. One BluWood sample also exhibited evidence of decay on the middle board of the sandwich (Figure 7).

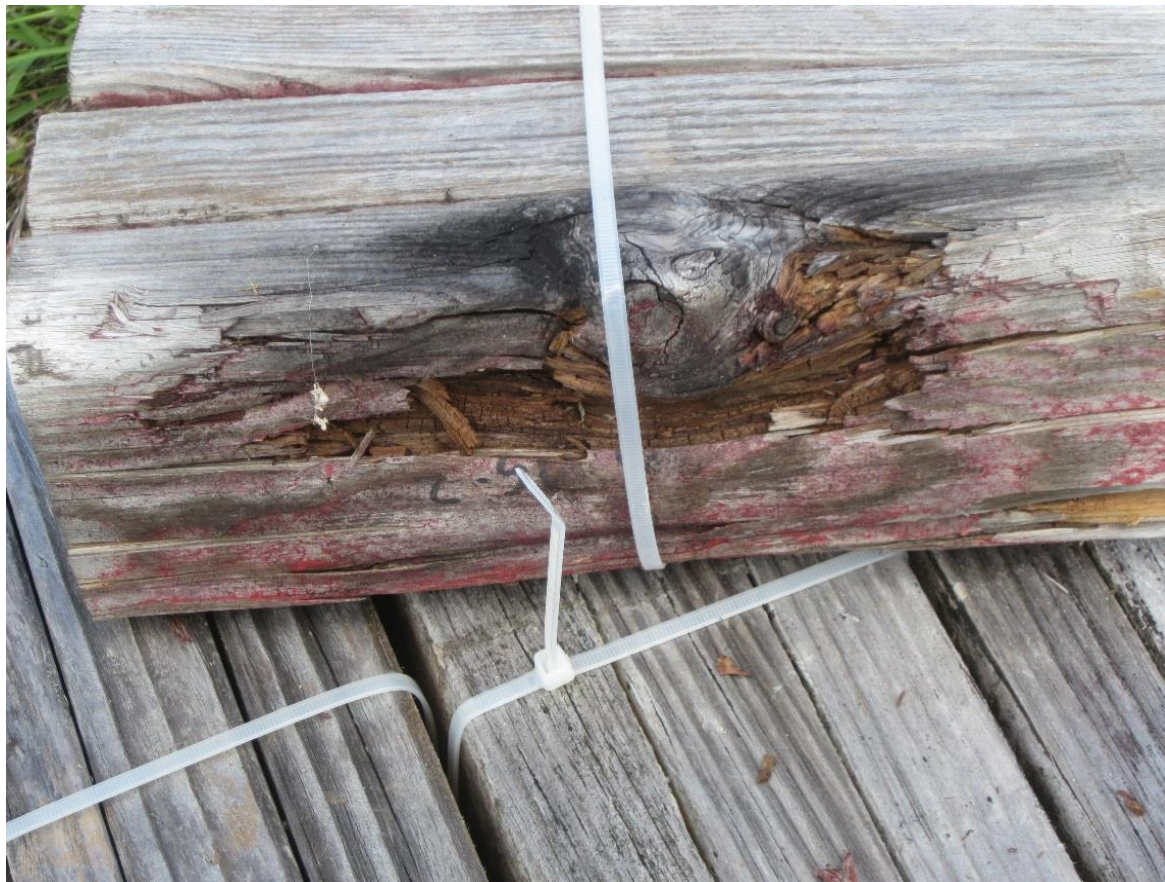
Figure 8. Example of an EcoRed Shield I sandwich showing advanced decay on the outside of the sandwich.

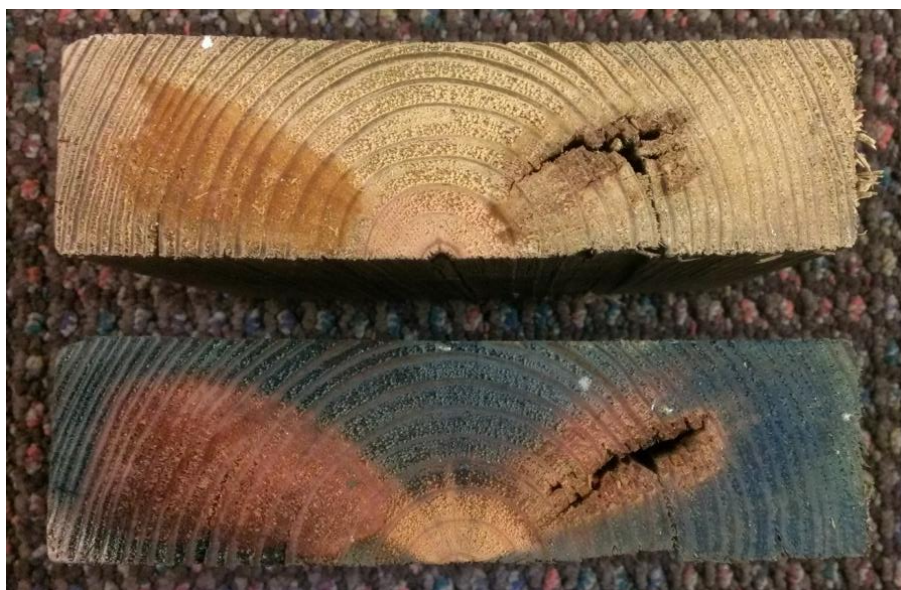
ACQ and CA-C have been seen to have decay issues within 5 years of service due to preservative penetration and detoxification issues (Chrome Azurol-S reagent shows remining active copper as blue).

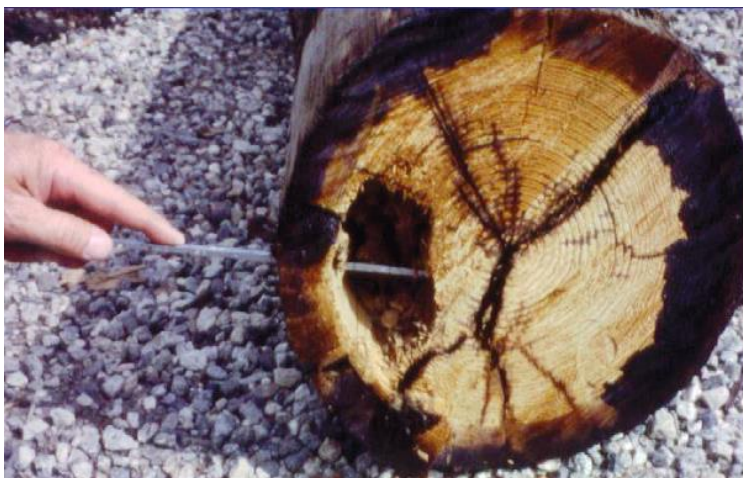
Untreated heartwood of a Douglas fir utility pole showing internal decay cavity.

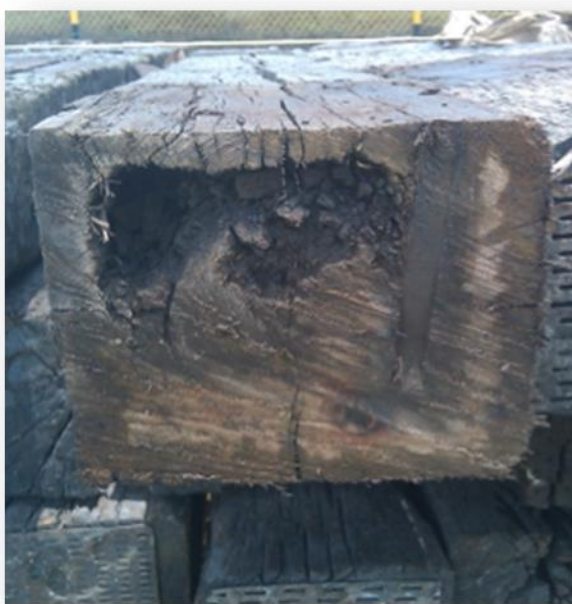
Creosote does not penetrate the heartwood and so only the envelope of ties is protected from decay as can be seen in the sectioned crosstie taken out of service.

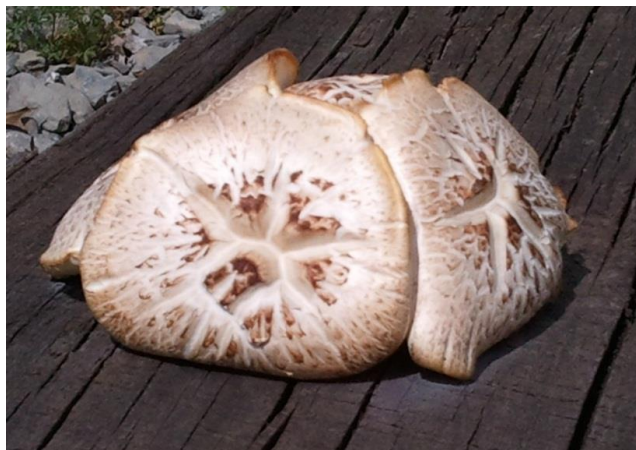
***Neolentinus lepideus*, “The Train Wrecker” growing on a creosote treated bridge timber.**

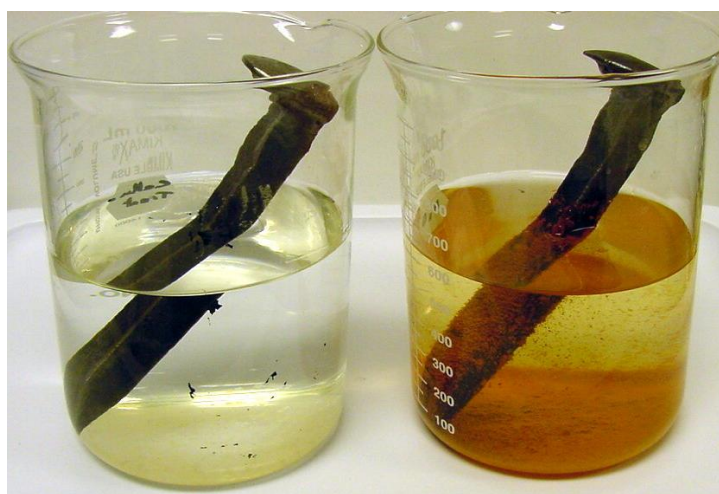
Rail spikes place in a beaker of 1 % DOT (left) and water (right) show the anti corrosion benefits of sodium borates (48 hours).

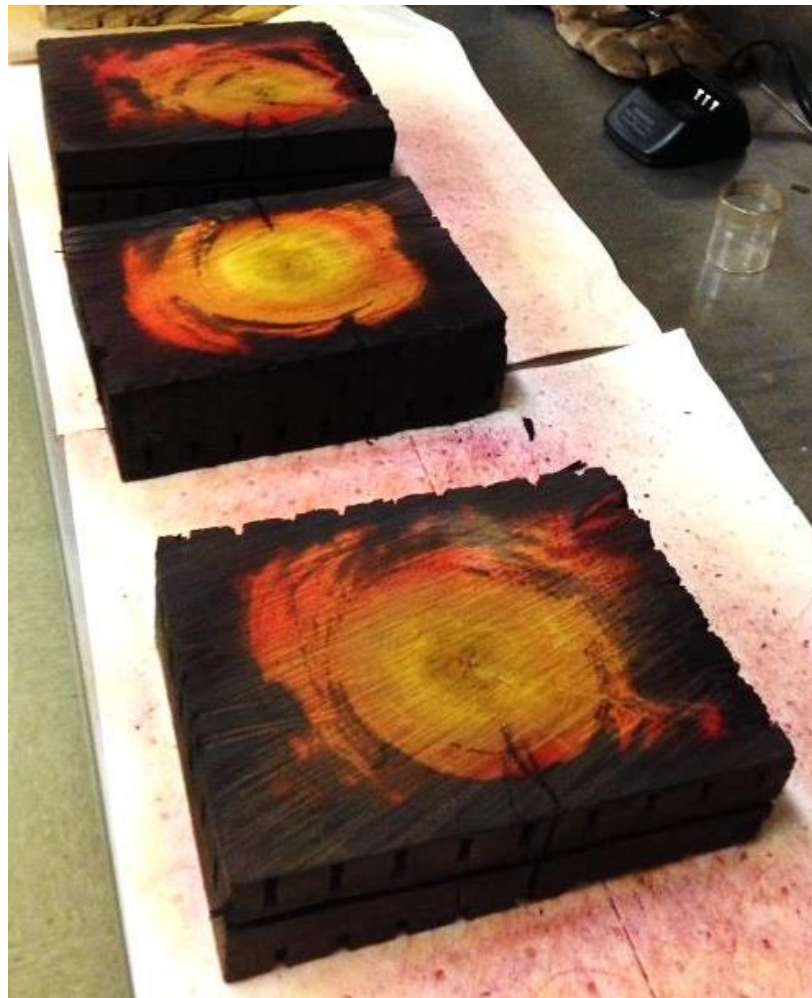
New two-step tie sections cut and curcumin sprayed (borate shows as red/orange after Smith and Williams 1969) courtesy of Dr. Nate Irby Union Pacific. Borate penetration can be seen to be much greater than the creosote penetration, even at this early stage of tie life.

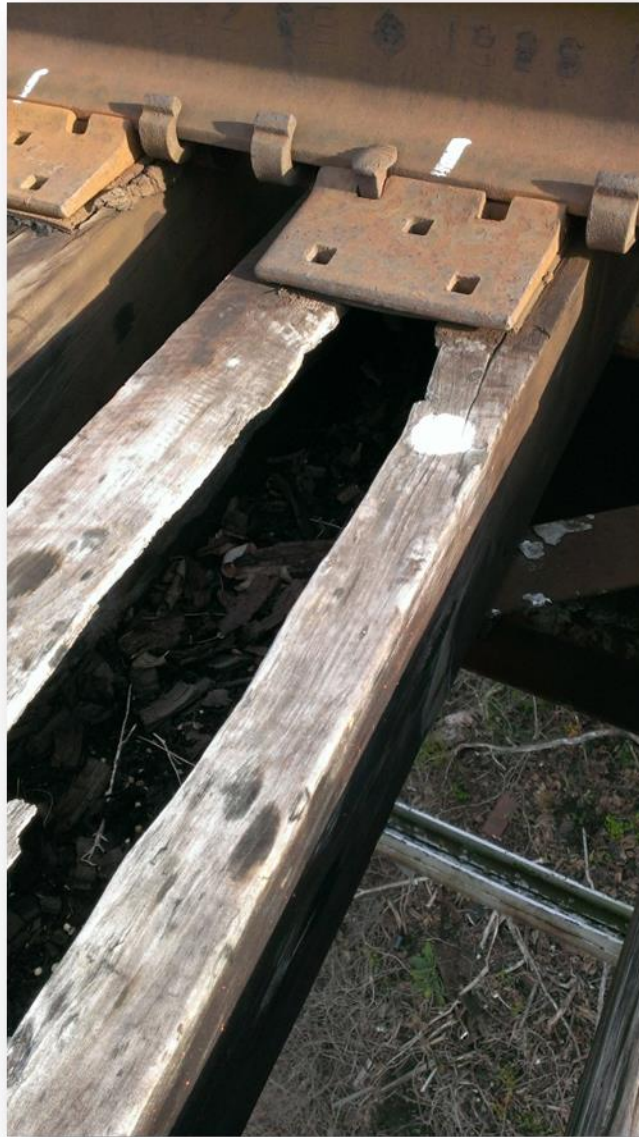
In the South East USA, creosote only bridge tie average life is about 16 years. Here the heartwood of this gum bridge tie is completely gone.

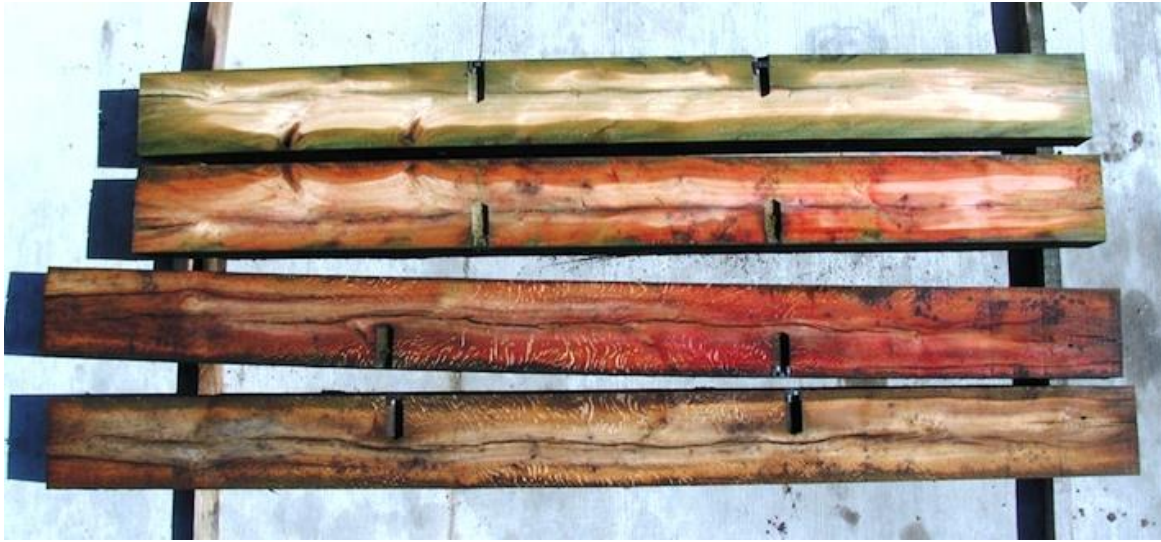
Commercially dual treated borate (Cellutreat® liquid 50) and copper naphthenate (QNAP®8) bridge timbers. Timbers have been rip sawn after borate and plug BTX® installation and Boulton treatment, and one half subsequently curcumin sprayed (Smith and Williams 1969) to show the presence of borate (red).

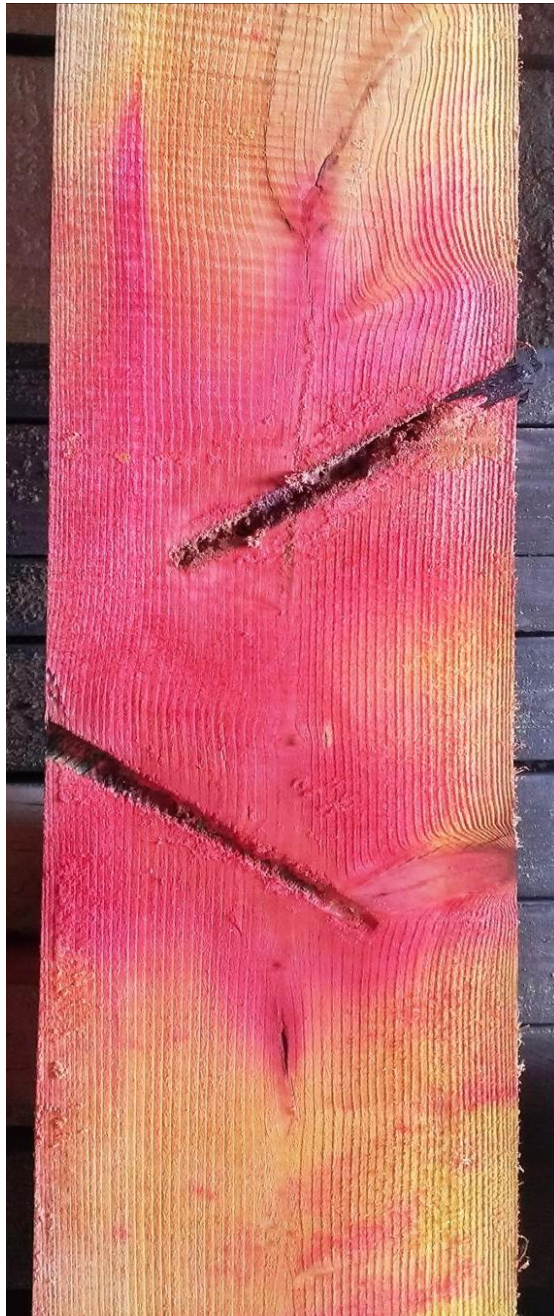
Douglas fir utility pole rip sawn and curcumin sprayed for boron immediately after treatment (shown as red after Smith and Williams 1969). The diagonal holes were filled with an aqueous borate concentrate (Cellutreat[®] liquid 50) and the pole was then Boulton treated in Copper Naphthenate (QNAP[®]8).

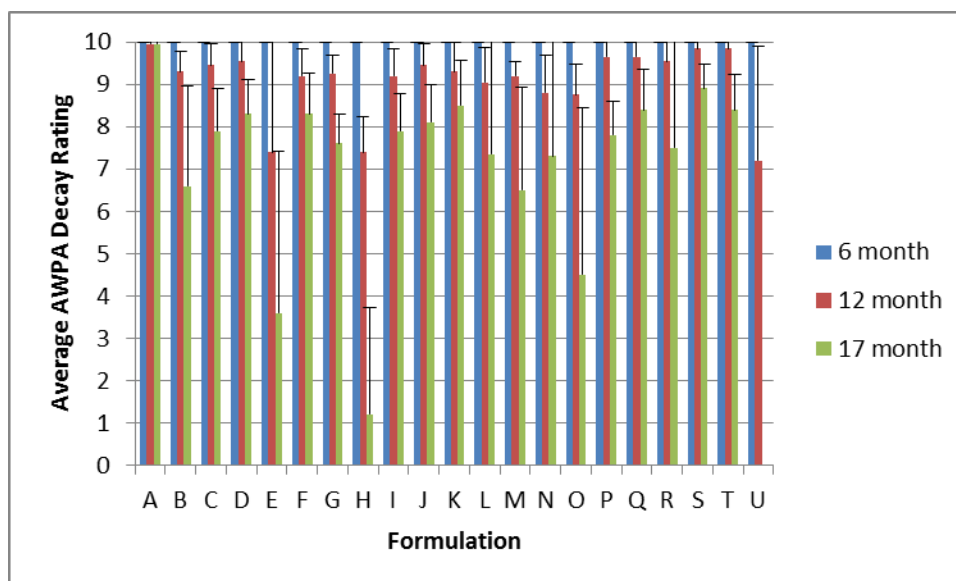
Figure 1. Average decay ratings in the basidiomycete bed

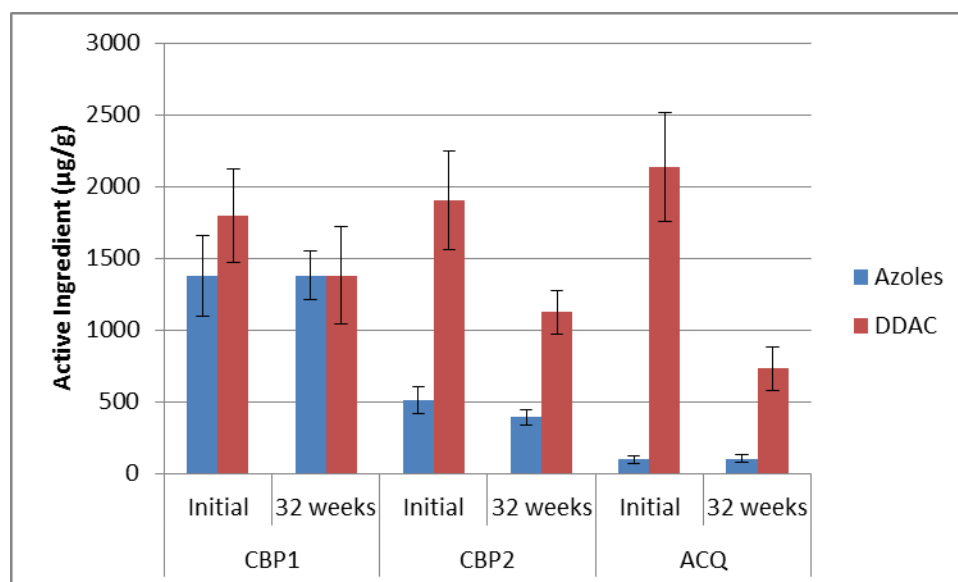
Figure 3. Depletion of azoles and DDAC after 32 weeks of soil exposure

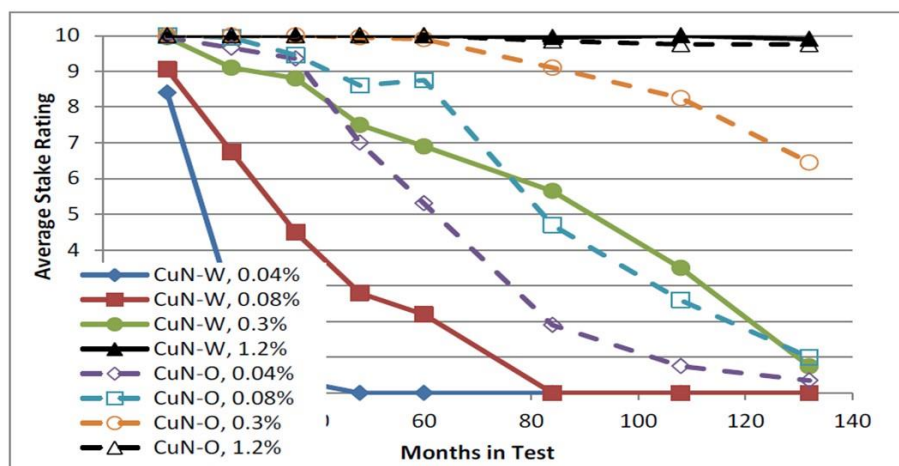
Figure 1. Stake test results for oil-borne and waterborne copper naphthenate

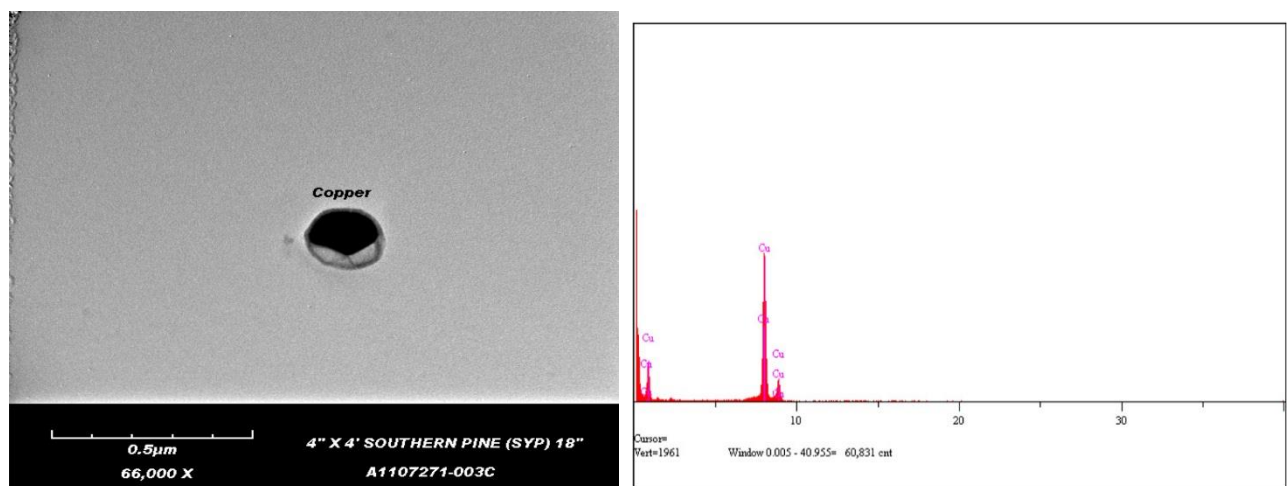
Figure 14. TEM Micrograph and EDS Spectrum Showing Free Copper Particles from ACQ-D @3.2 kg/m³ kg/m³ Treated Wood
