Factors affecting the service life of poles in BC

Leon A. Joseph

**British Columbia Hydro
Engineering Quality Management
Burnaby, B.C.**

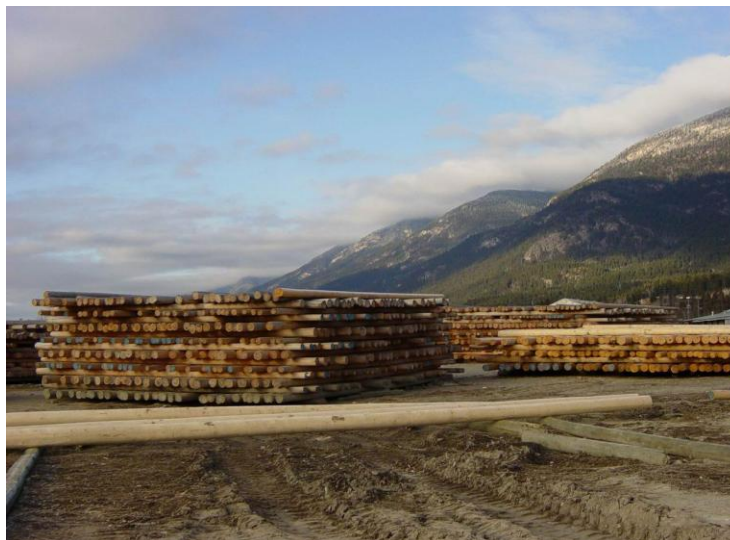
Regardless of the species, the amount of time that passes from harvesting to bark removal can have an impact on the service life of a pole. Following bark removal, the manner in which poles are stored is also important. Photo 7 presents a good example of a storage yard that is free of vegetation and standing water. Poles should be stacked in a manner that allows for air circulation.

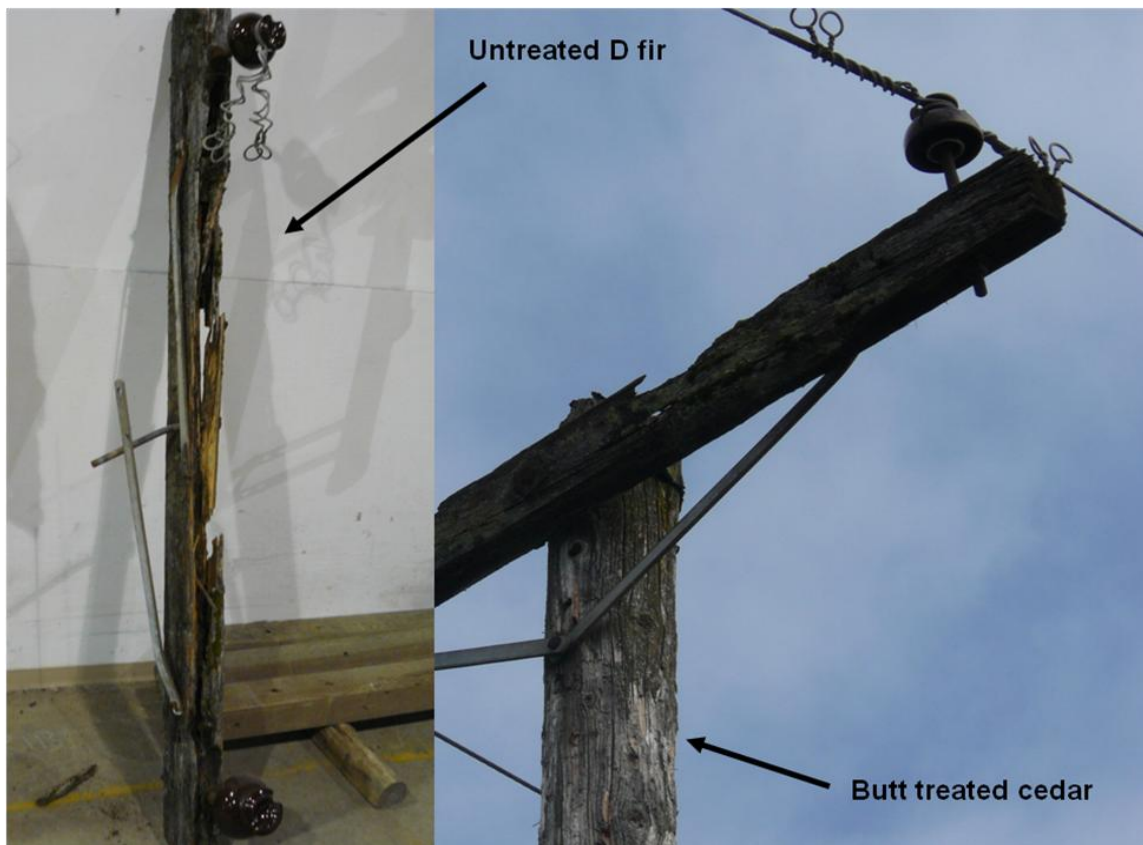
Photo 8

It was also noted that untreated Douglas fir crossarms attached to butt-treated poles did not perform as well as the crossarms attached to full-length treated ones. (Prior to the late 1960s, all the crossarms in BC Hydro's system were untreated.) When top rot developed in a butt-treated pole, the decay soon spread to the untreated crossarm. (photo 8) This observation prompted BC Hydro to reformulate its Test & Treat procedures, which primarily focused attention on the ground-line zone of a pole. Today, maintenance and line crews are required to assess the condition of the entire body of a pole, as well as the crossarm. The remaining butt-treated poles installed in coastal areas are currently being monitored to ensure they do not pose a safety hazard.

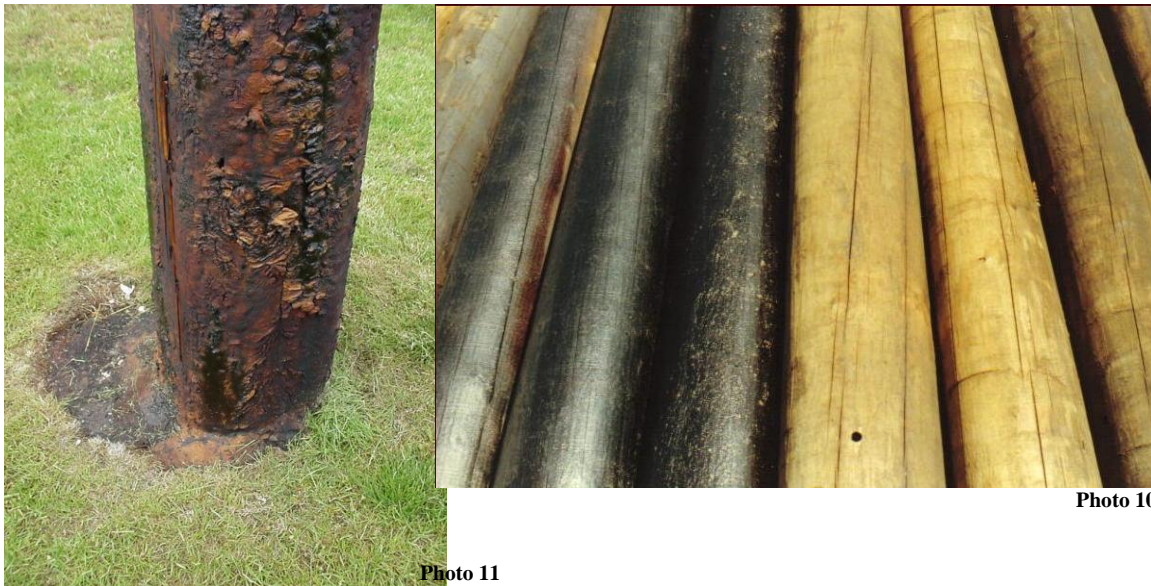
Tests were performed on several BC Hydro owned storage facilities to determine the level of contamination that was believed to be present under pole decks. The test results revealed that the soil contained levels of Pentachlorophenol that was considerably higher than anticipated. (photo 10) This proved to be a very costly lesson learned that reinforced the need to ensure that treated poles and timbers did not experience chemical bleeding.

The heightened environmental awareness was also reflected in the number of complaints received from field crews and local residents. Attempts to clean poles that were experiencing chemical bleeding after installation were mostly unsuccessful. (photo 11) The exercise only served to generate more concern and suspicion.

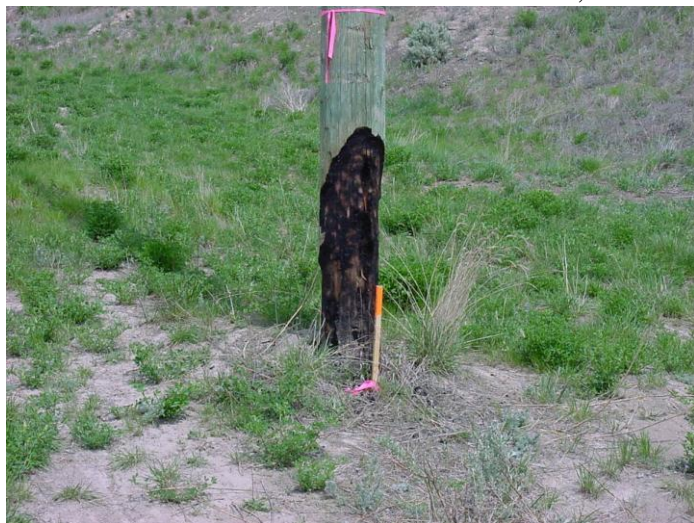
Photo 13

On a more positive note, when exposed to fire, Penta-treated material tends to fair considerably better than that of CCA or ACA treated wood. In most cases, the fire damage is only superficial. In contrast, salt treated poles often experienced a condition known as afterglow or "embering" that can slowly consume a pole after a grass fire is extinguished. (photo 13) It appears that the absence of visible flames causes the person tending the fire to presume that it is out and that the exercise did not damage the pole.

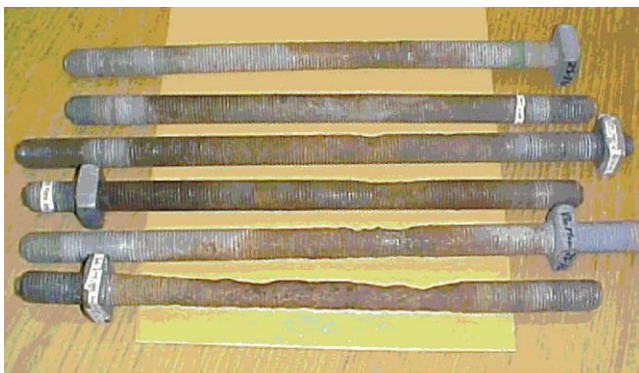
Photo 14

In 1984, BC Hydro abandoned the use of ACA treated poles. Though ACA was a very effective wood preservative, its corrosive nature severely damaged the metal hardware attached to freshly treated material. (photo 14) On many occasions, crews had to replace the pole bolts after one year of service.

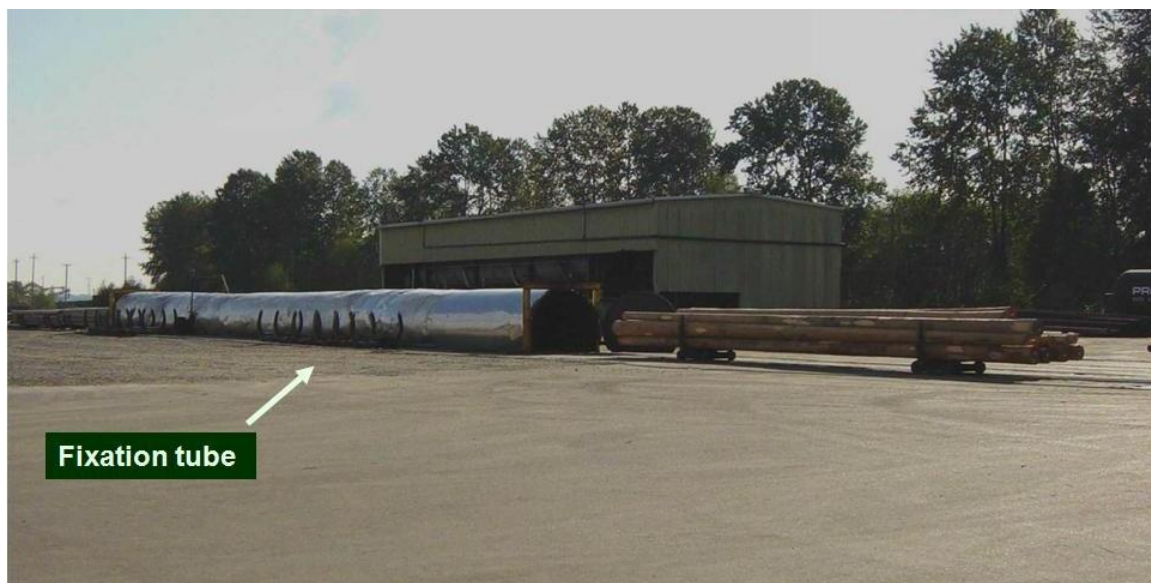
In 1996, BC Hydro revised its wood pole specification to require a mechanical fixation process of all CCA treated material. The purpose of this revision was to ensure that Chrome VI was not present in the poles or timbers delivered to storage yards or construction sites. BC Hydro did not specify the particular method that a supplier had to employ in order to achieve complete fixation. They could use a conventional dry kiln, a steam tunnel or a hot water bath. Photo 15 shows the first fixation tunnel to operate in British Columbia. It was a little rustic, but it did the job.

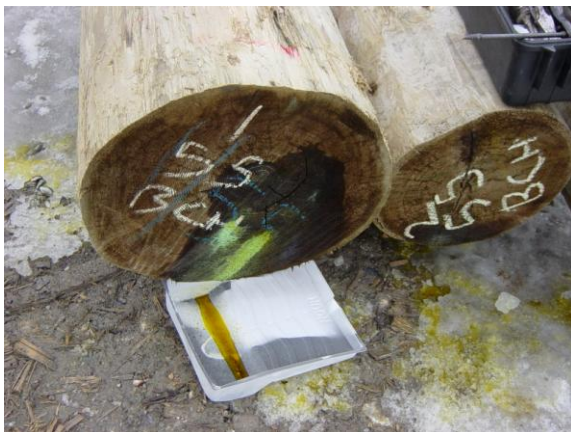
Photo 16

The CSA 015 Wood Utility Pole Standard permits ***firm red heart*** in poles. This provision is problematic because very few pole graders can differentiate incipient decay from firm red heart. The Standard also permits the decay in the knots and the butt of a pole.

These defects can pose a chemical bleeding problem for poles that are treated during subzero temperatures. CCA solution saturates the areas containing decay, but does not bind to the damaged wood fiber. When the poles are removed from the treating cylinder, the free CCA solution inside the damaged areas can freeze solid. Days or weeks later, when the pole is exposed to warmer temperatures, the frozen CCA solution melts and drains out the decayed areas. (photos 16 & 17) This can result in the contamination of a storage yard or a construction site.

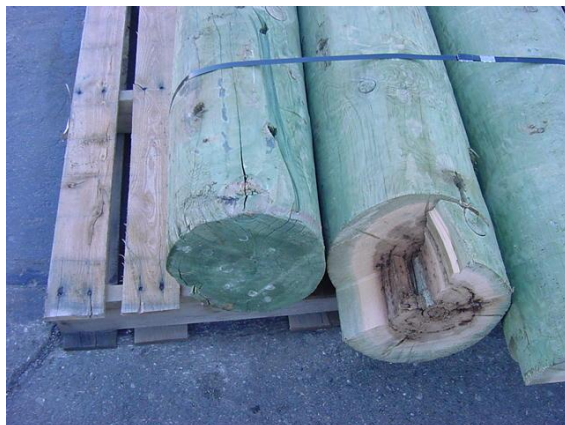
Photo 19

Internal heart rot can develop in the body of a living tree. During manufacturing, there may be no evidence of the rot on the outer surface of a pole, including the top or the butt. (photo 19) If the internal damage is extensive, the pole will most likely break during handling or installation. Whatever the case, any pole failure has the potential to cause personal injury or collateral damage. For a utility, identifying safety hazards and preventing accidents is a top priority.

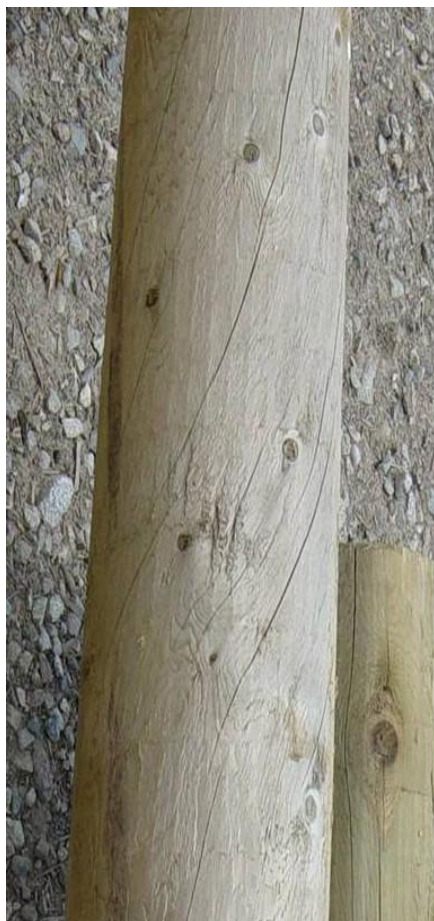
Photo 23

Right-hand

The difference between a right-hand and a left-hand spiral is not solely the direction of the grain. During the first few years of a tree's life, its grain usually grows in a straight upward direction. It may wander slightly to the right or left then return to straight. As the tree approaches maturity, a more dramatic clockwise spiral may develop. This is called a right-hand spiral or a sapwood spiral. (photo 23) BC Hydro has determined that a pole that contains a right-hand spiral rarely experiences any degree of twisting. It is believed that there is sufficient straight grain in the body of the pole to counteract the forces generated in the spiralled grain when natural shrinkage occurs.

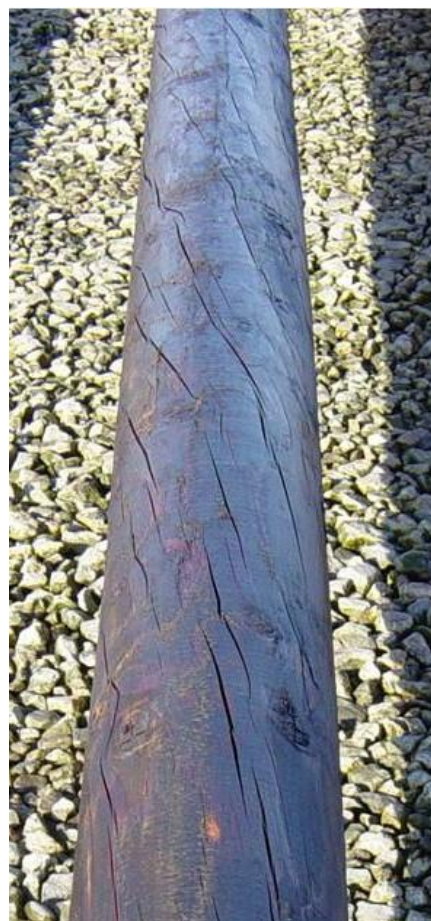
Photo 24

Left-hand

In contrast, a left-hand spiral develops at the pith of a tree and continues to grow in a counter-clockwise direction throughout the tree's life. (photo 24) Since there is no straight grain present, when the wood fibre dries and shrinks, the spiral tightens thus causing a pole to twist.

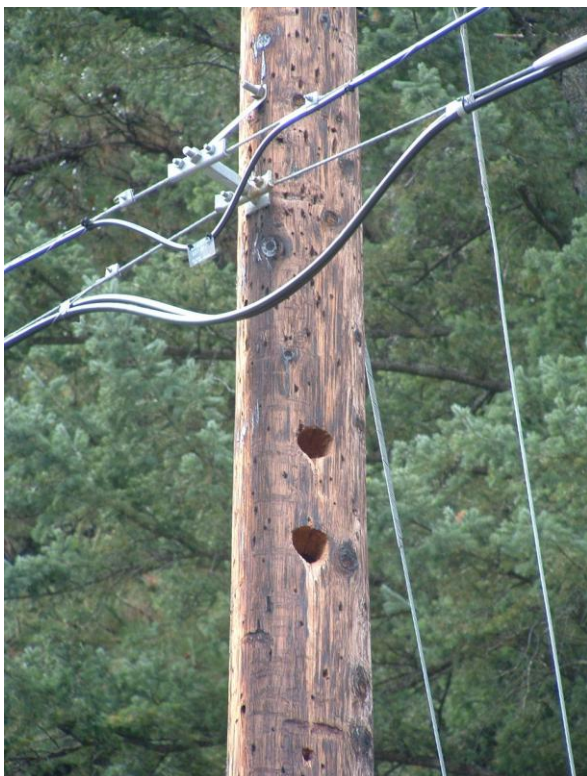
Photo 29

When discussing climate change, subject experts often refer to a chain of events that is predicted to affect the Earth. For wood poles, the third link in the enemies of wood chain would have to be the **woodpecker**. (photo 29) Where there is decay, there are insects and where there are insects, there are woodpeckers. Southern British Columbia appears to be experiencing a huge increase in the woodpecker population. This conclusion is based on the number of complaints that have been received from field crews regarding woodpecker damage. Reports from the Gulf Islands and Vancouver Island claim that the number of poles that contain woodpecker holes has reached an unprecedented level.

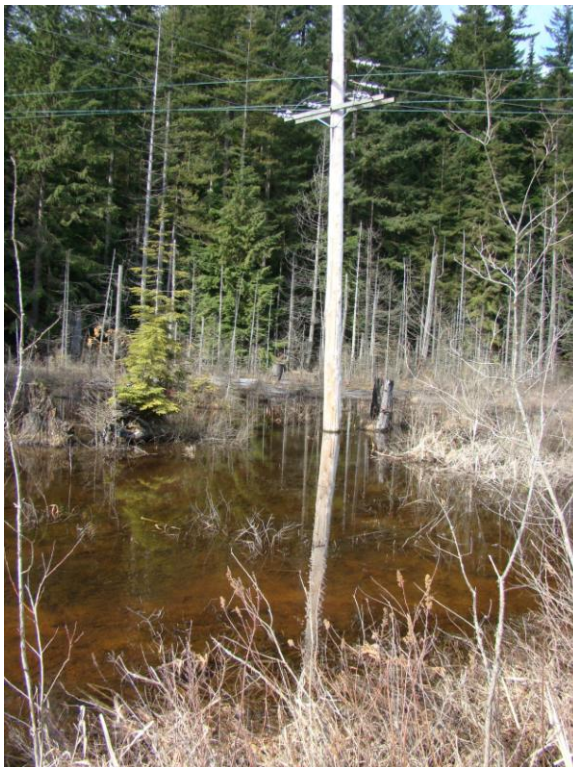
Photo 31

The activities of *non-utility individuals* can also have an impact on the service life of a wood pole. This is a very difficult challenge for a utility to address. In most cases, the damage is unintentional and does not come to the attention of a utility until there is a problem.

Example: It was recently discovered that a land development project unintentionally diverted a small underground stream. This resulted in the formation of a pond in a forest area, which is located below the development. (photo 31) Unfortunately, there was a wood pole line in the area now flooding. Since there is no way to drain the area, it is no longer possible to apply remedial treatment to the poles, which are standing in water.
