Conclusions and Summary Report Environmental Life Cycle Assessment of Highway Guard Rail Posts

ISO 14044 Compliant

Prepared by: AquAeTer, Inc.

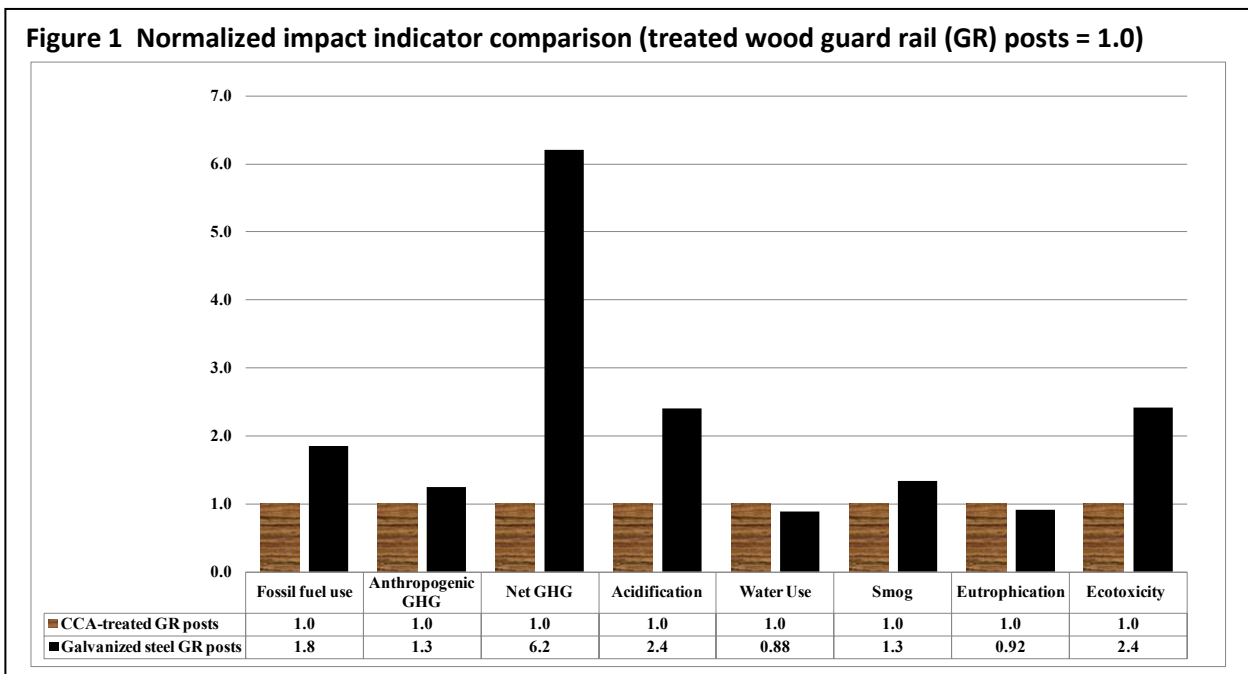
Impact indicator values were normalized to better support comparisons between products and to understand the quantitative significance of indicators. Product normalization sets the cradle-to-grave life cycle value of treated wood highway guard rail posts to one (1.0) with galvanized steel highway guard rail post impact indicator values being a multiple of one (if larger) or a fraction of one (if smaller). The normalized results are provided in Figure 1.

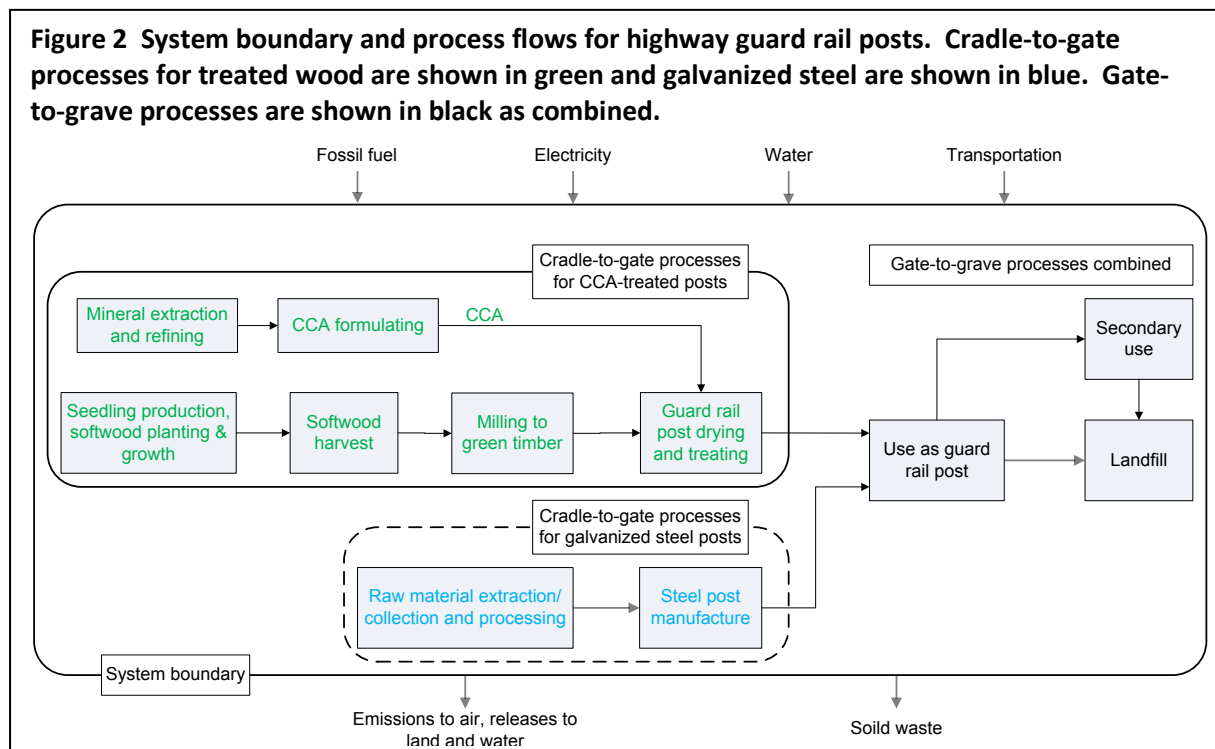
The system boundaries include all the production steps from extraction of raw materials from the earth (cradle) through to final disposition after service life (grave). Figure 2 illustrates the system boundaries and process flow for both wood and non-wood highway guard rail posts assessed in this study.

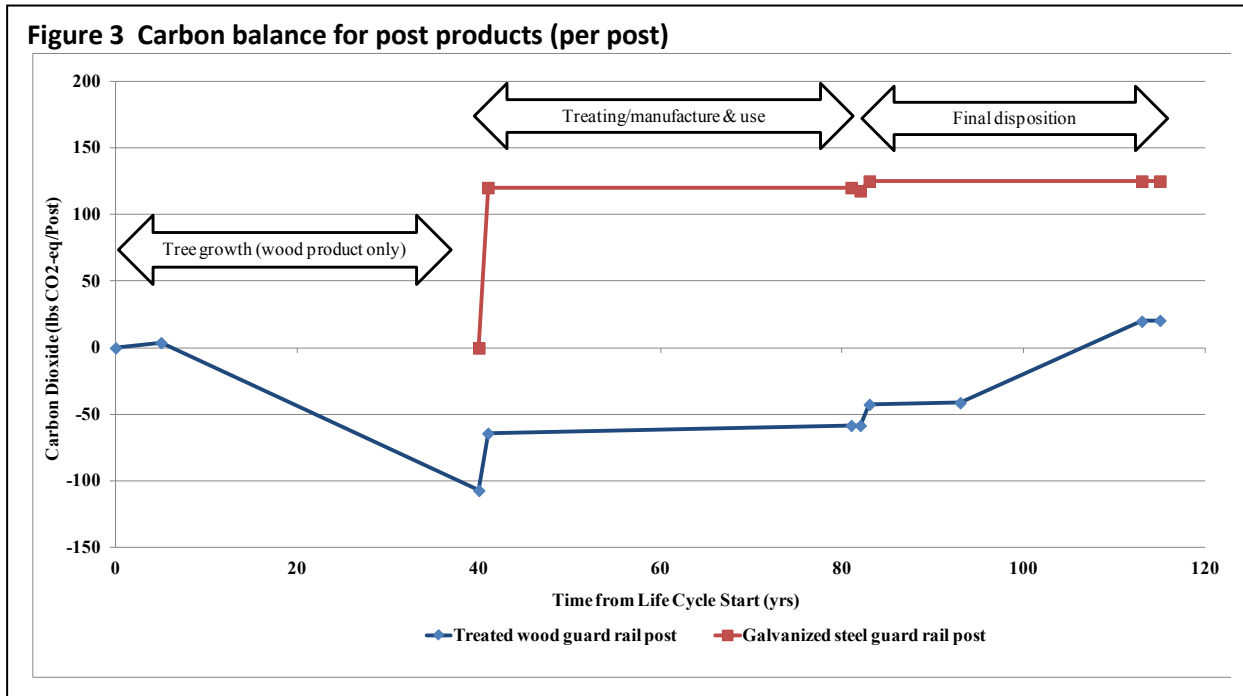
Minimal impacts are required for both treated wood and galvanized steel in the service life stage. Following the service life stage, wood posts are recycled for secondary uses or disposed in landfills. Galvanized steel guard rail posts are assumed recycled. The carbon balance of highway guard rail posts, through the life cycle stages, is shown in Figure 3.

Wood products begin their life cycles removing carbon from the atmosphere (as carbon dioxide) and atmospheric carbon removal continues as trees grow during their approximate 40-year growth cycle, providing an initial life cycle carbon credit. Approximately half the mass of dry wood fiber is carbon. Transportation and treating operations are the primary sources of carbon emissions in the manufacture of treated wood products.

The galvanized steel post begins its life cycle either as a raw material or with the recycling of steel products. Both processes result in carbon emissions. Burdens associated with recycling, including transportation, sorting, cleaning, and melting, must be included in the manufacturing stage.
