FIELD PERFORMANCE OF TRANSPARENT COATINGS

K. Groves, S. McFarling and P. I. Morris
Forintek Canada Corp., 2665 East Mall, Vancouver, B. C. V6T 1W5

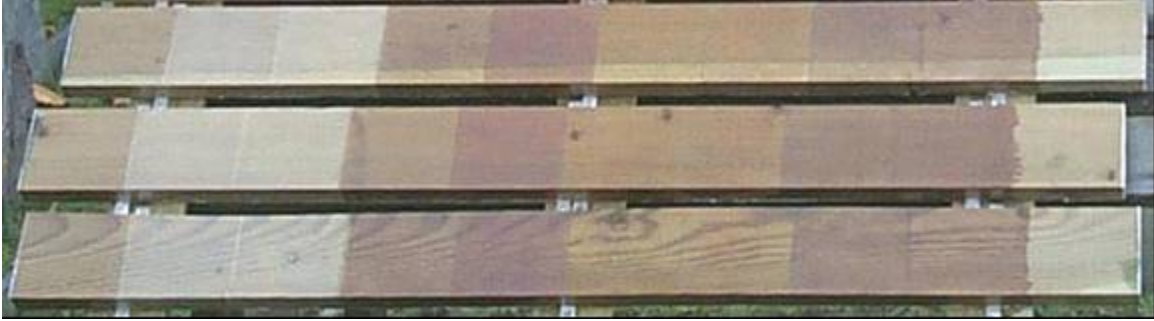
Figure 1: Example of siding immediately after installation, CCA-treated. F1 to F9 and control from left to right.)

Coatings #F1-F9 were brush applied to the siding (1.52 m siding samples) in the Vancouver laboratory, according to manufacturers' instructions. The locations are shown in Figure 1. All the coatings were applied to the planed side and the two edges (one planed and one rough). Coating combinations F1, F3, F5, F7, and F9 were applied first, using painter's tape to prevent over brushing, the coatings were allowed to dry for 72 hours. The remaining coating combinations, F2, F4, F6, and F8 were then applied, again using painter's tape to prevent over brushing, and allowed to dry. Between all coatings a 6 mm overlap was used. For the 45-degree test fences at both test sites, there were 3 replicates prepared for each F1-F9 coating combination per pre-treatment.

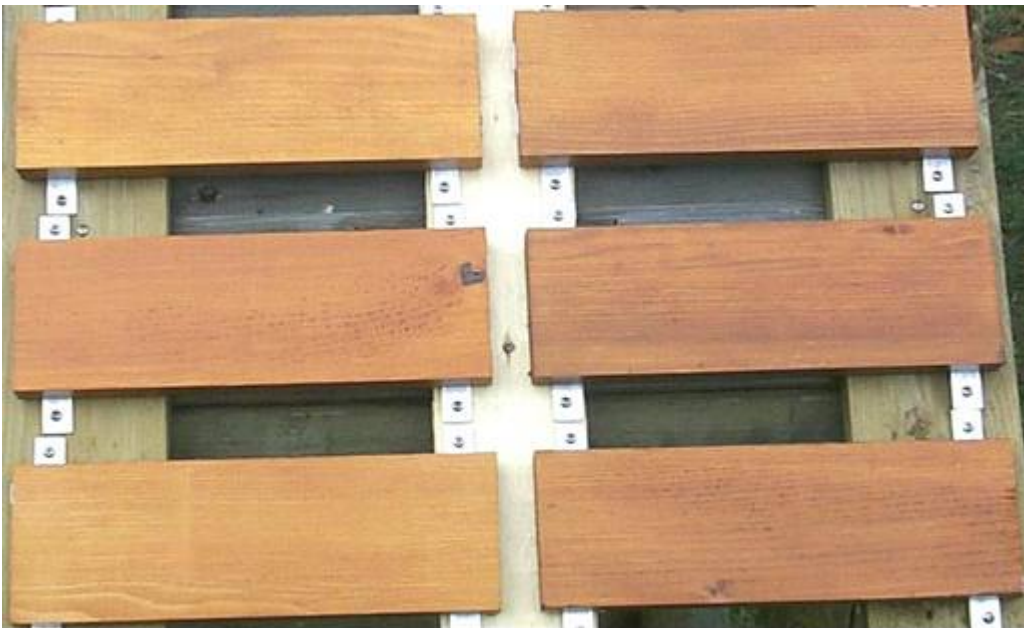
Figure 2: Short boards

Only coatings #F2, F5, F7 and F9 were applied to the short boards (Figure 2). These were also brush applied in the Vancouver laboratory, according to manufacturers instructions. The coatings were applied to all 6 sides. For the 45-degree test fences at both test sites, there was 1 replicate prepared for each F1-F9 coating combination per pre-treatment.

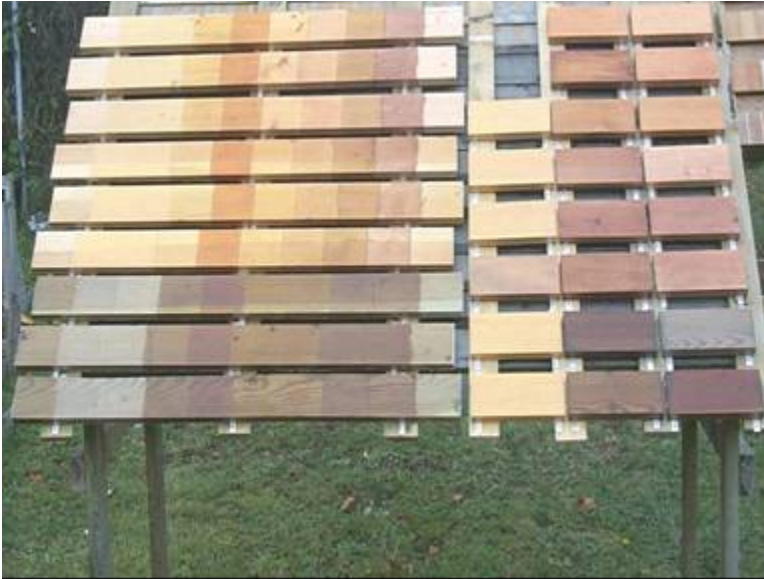
Figure 3: Vancouver south-facing 45° platform

45° platforms (Figure 3). The samples were attached using aluminium brackets and stainless steel screws. The brackets were screwed to the back of the samples.

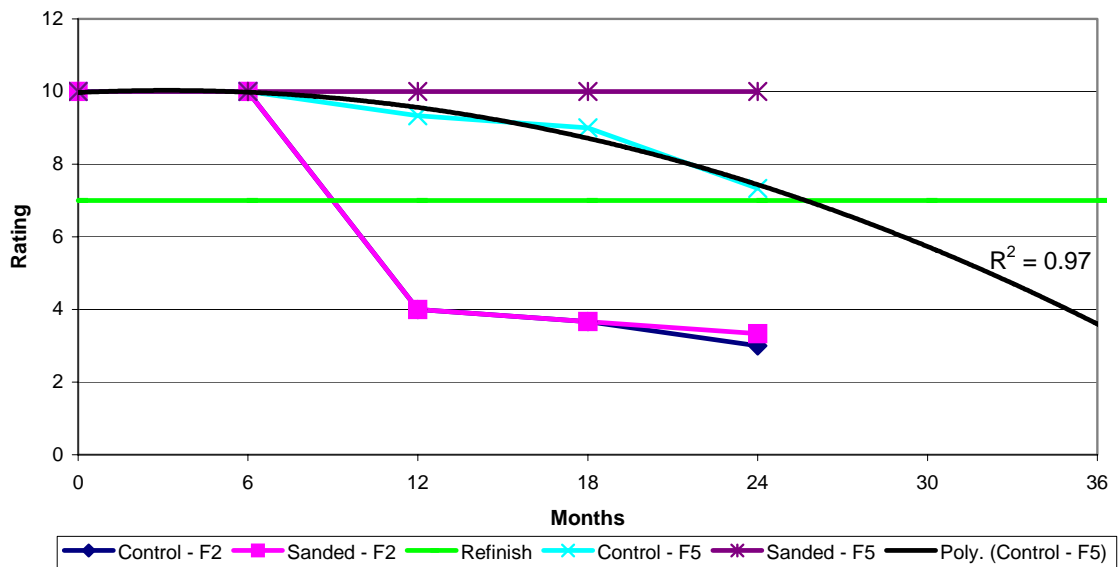
Figure 6: Change in average general rating over time for selected coatings with and without sanding in Vancouver.
